Restoring a First Order Stream and Adjacent Riparian Wetlands In West Virginia: Integrating Lessons from Science and Practice

Andrew MacKenzie¹, Walter E. Veselka, Paul Kinder, Michael P. Strager, Shawn T. Grushecky, Jason A. Hubbard, and James T. Anderson²

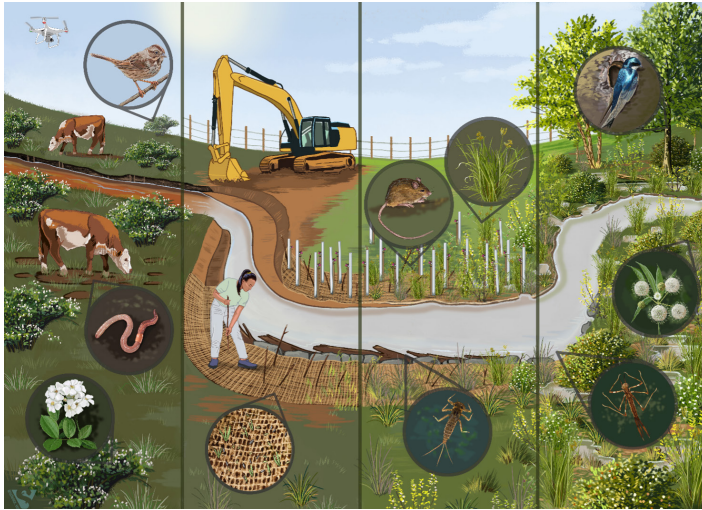
Visual Abstract. Panel 1 (left; Pre-Restoration): A degraded wetland as a cattle pasture featuring song sparrows (*Melospiza melodia*), earthworms (*Oligochaeta*), and multiflora rose (*Rosa multiflora*). Panel 2 (Active Restoration): Streambank grading, seeding, coir mesh installation, live-staking, rock vanes, wood vanes, and woody vegetation planting. Panel 3 (Post-Restoration); Early restoration habitat, featuring meadow jumping mice (*Zapus hudsonius*), yellow flatsedge (*Cyperus flavescens*), flat-headed mayflies (*Eperous* sp.). Panel 4 (Future Outlook); Projected outlook of our restoration featuring tree swallows (*Tachycineta bicolor*), common buttonbush (*Cephalanthus occidentalis*), and narrow-winged damselflies (*Enallagma* sp.). (Scientific Illustration by J. Spahr Science Visuals; permission to use granted.)

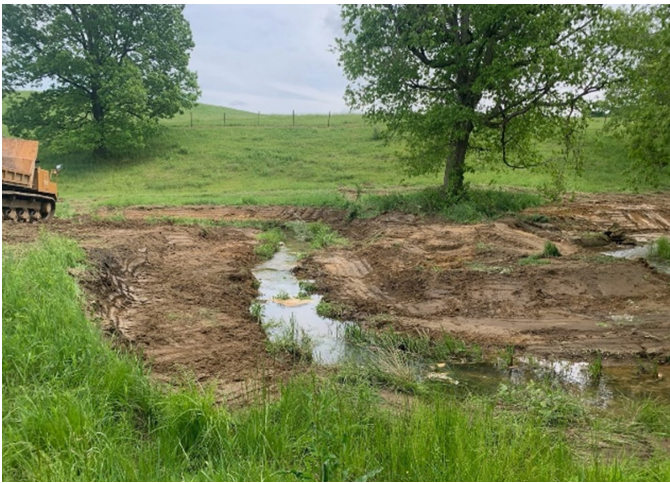
Figure 2. The streambank grading of Ruby Run and the adjacent wetlands, Preston County, West Virginia, USA. (Note: All photos taken by Andrew MacKenzie)

In June 2021, the WVCA and contractors started restoring the degraded Ruby Run. The stream was heavily incised, resulting in head cuts and eroding banks that were unstable and contributed pulses of sediment during rain or disturbance events. The restoration design plan called for creating a bankfull bench to act as a floodplain with occasional pocket wetlands at the toe of the slope (Figure 2).

The stream design called for a 3:1 slope to create a 6-foot (1.8 m) wide bankfull bench on each side of Ruby Run. Using an excavator, the stream banks were graded from the upstream property line, 420 m downstream. Topsoil was staged and respread after excess debris and soil were removed from the easement area. Log vanes, rock vanes, and point bars were placed on the outside edges of highly erodible bends (Figure 3), requiring one extraneous load of rocks that resembles a riprap bed needed to armor the confluence of a wet-weather seep and the stream at the beginning of a turn (Figure 4).

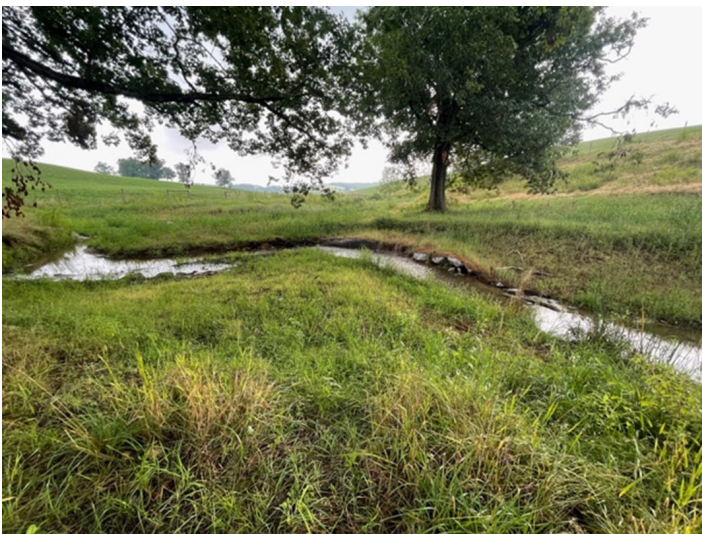
Figure 3. Wet-weather seep before being armored with rocks resembling riprap along Ruby Run's streambank in Preston County, West Virginia, USA.

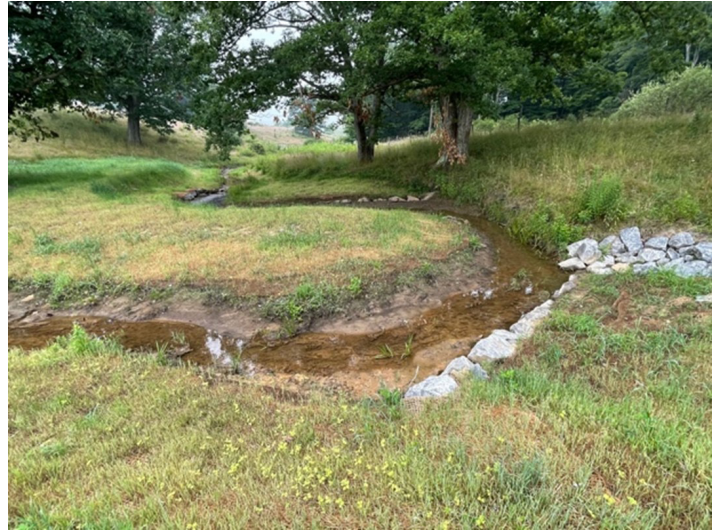
Figure 4. Log vanes, rocks vanes, point bar, and rocks resembling riprap along Ruby Run's streambank, Preston County, West Virginia, USA.

In addition to stabilizing the banks, multiple instream structures (coarse woody habitat, rock j-hooks, and root wads) were added to reduce channel velocity and provide cover for aquatic organisms (Rosgen 1996). These structures include a cobble bed to stimulate and promote riffle habitat and two root wad features sticking out of the floodplain.

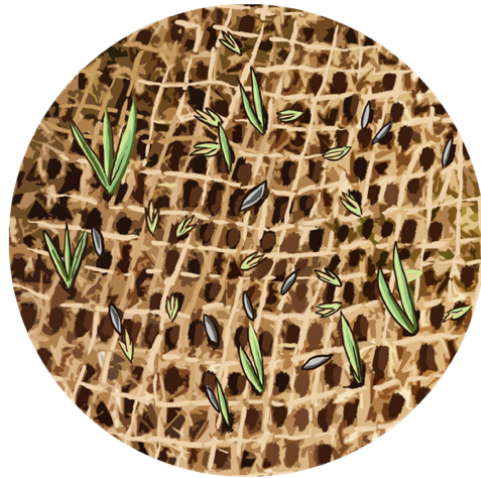
Figure 5. Vegetation sprouting underneath coir mesh. (Scientific Illustration by J. Spahr Science Visuals, permission to use granted.)

2021), the WVCA seeded the exposed bank with native perennial vegetation (Ernst Conservation Seeds Eastern Native Habitat & Conservation Reserve Enhancement Program (CREP) Mix; Table 1) along the slopes and a native floodplain cover crop (Ernst Conservation Seeds Floodplain Mix; Table 2) for the bankfull bench. After seeding, mesh coir mats were installed to reduce erosion or the loss of seeds through wind or water erosion (Figures 5 and 6).

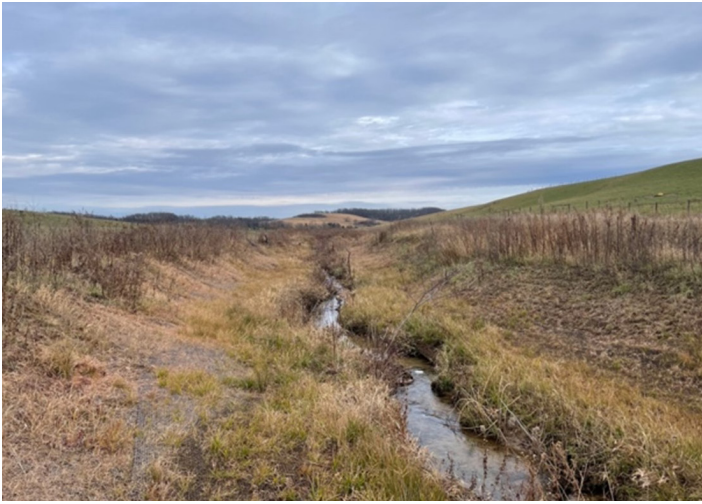
Figure 6. Vegetation growth six months (12/15/2021) after coir mesh installation along Ruby Run, Preston County, West Virginia, USA.

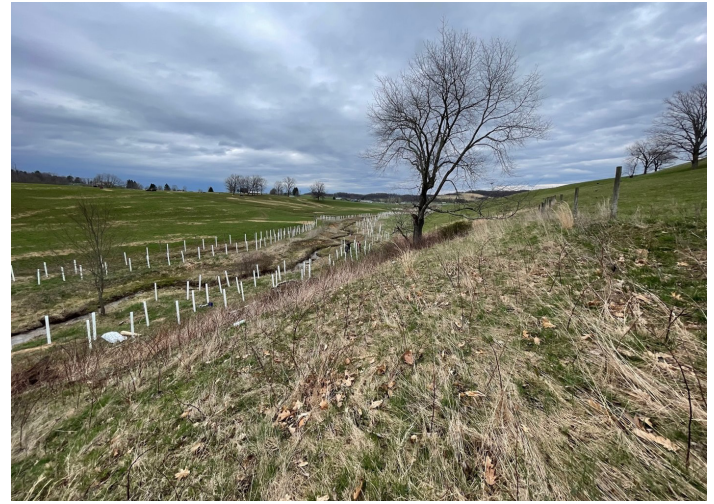
Figure 7. Woody Vegetation Installed along Ruby Run and within the adjacent wetlands, Preston County, West Virginia, USA.

Native woody vegetation was planted between March and May 2022 (Figure 7). The wettest areas along the bankfull bench were planted with common buttonbush (*Cephalanthus occidentalis*), eastern ninebark (*Physocarpus opulifolius*), pin oak (*Quercus palustris*), and river birch (*Betula nigra*). The top of the bank and drier reaches of the floodplain were planted with American plum (*Prunus americana*), eastern cottonwood (*Populus deltoides*), eastern redbud (*Cercis canadensis*), swamp white oak (*Quercus bicolor*), and river birch (*Betula nigra*). All woody vegetation was tagged with numbered aluminum tags (Racetrack, UNSPSC: 55121500) attached with zip ties (Figure 8a and

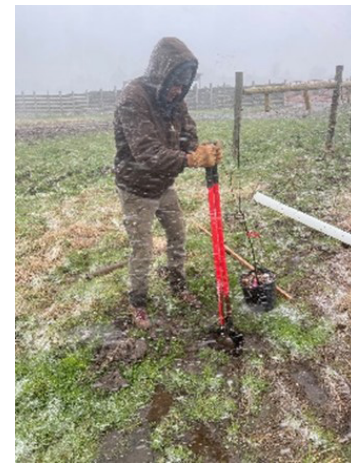
Figure 8a. Creating a hole for woody vegetation, Preston County, West Virginia, USA.

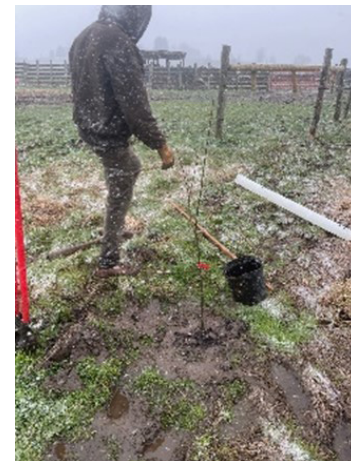
Figure 8b. Installing woody vegetation and closing the hole, Preston County, West Virginia, USA.

8b). Woody vegetation in the floodplain was planted with tree tubes (Max Grow, A.M. Leonard, SKU: MG60) held up by wooden oak stakes (Figure 8c and 8d). After the woody vegetation planting occurred, we added coconut fiber weed guards (44 cm. diameter; A.M. Leonard, SKU: CD44A) as weed control. In addition to weed control, we actively manage and remove invasive woody vegetation as it is observed.

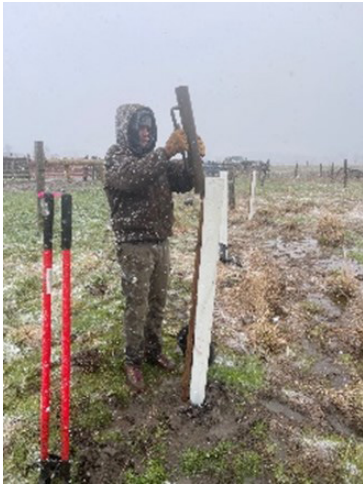
Figure 8c. Installing wooden stake and tree tube, Preston County, West Virginia, USA.

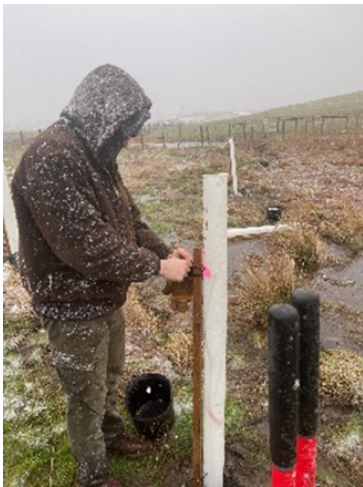
Figure 8d. Zip-tying tree tube and zip-tie to a wooden stake, Preston County, West Virginia, USA.
