Restoring Tidal Flow to a New England Salt Marsh

Ralph W. Tiner¹ and Michael O'Reilly

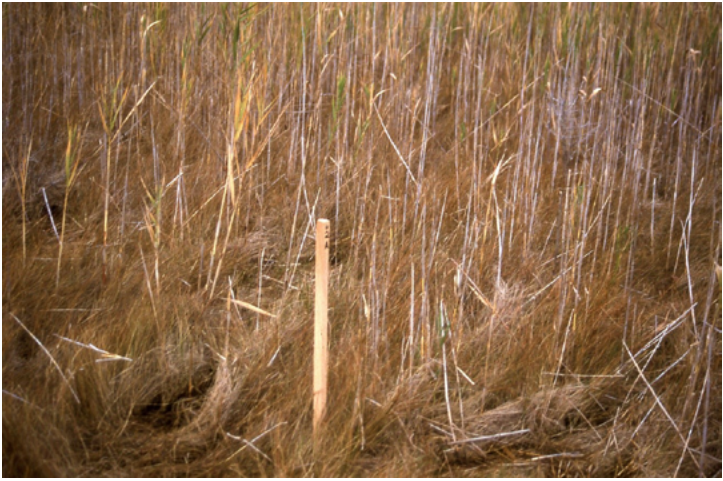
Figure 2. Plot 2A on October 31, 1995: mostly *Spartina patens* with some *Phragmites*. (R. Tiner photo)

In 1995, we established 15 study areas in the lower marsh to document the baseline conditions for informal monitoring of future changes. Sampling locations were chosen to represent areas with varying amounts of common reed, ranging from sparse cover to virtual monocultures (Figures 2-5). No sampling was done in areas solely represented by native species. At each site 2-4 nested plots (0.46m x 0.46m or 1.5ft x 1.5ft each) were evaluated for plant species, cover, and number and average height of *Phragmites* stems. Four plots were examined at the first two locations

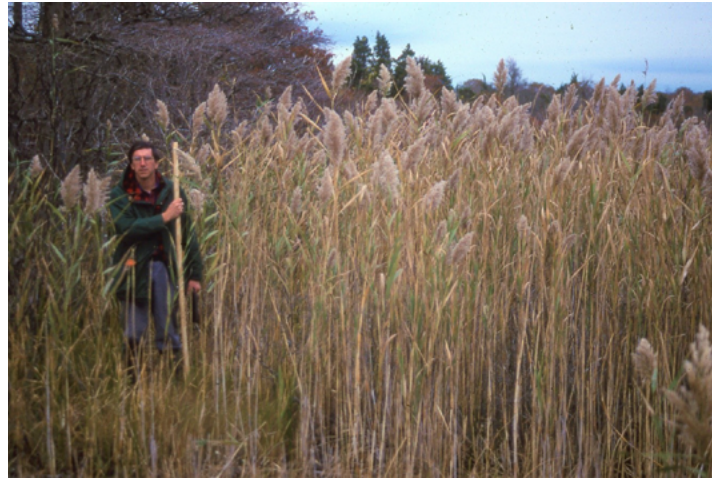
Figure 3. Mike at Plot 9B (a virtual monoculture of *Phragmites*) on October 31, 1995. (R. Tiner photo)

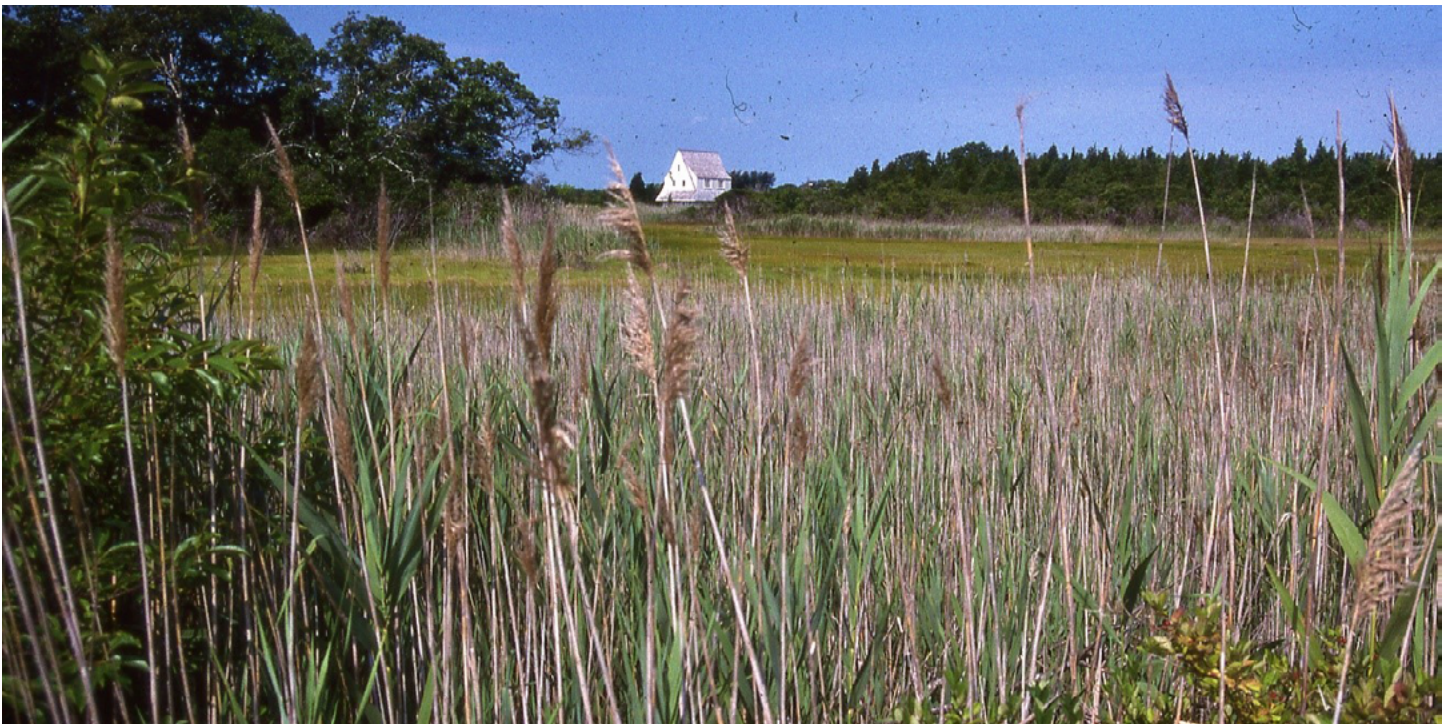
Figure 4. General location of Plot 15B in late summer of 1995 (just before initiating study), looking west from Cow Yard Lane – a robust stand of *Phragmites*. (R. Tiner photo)

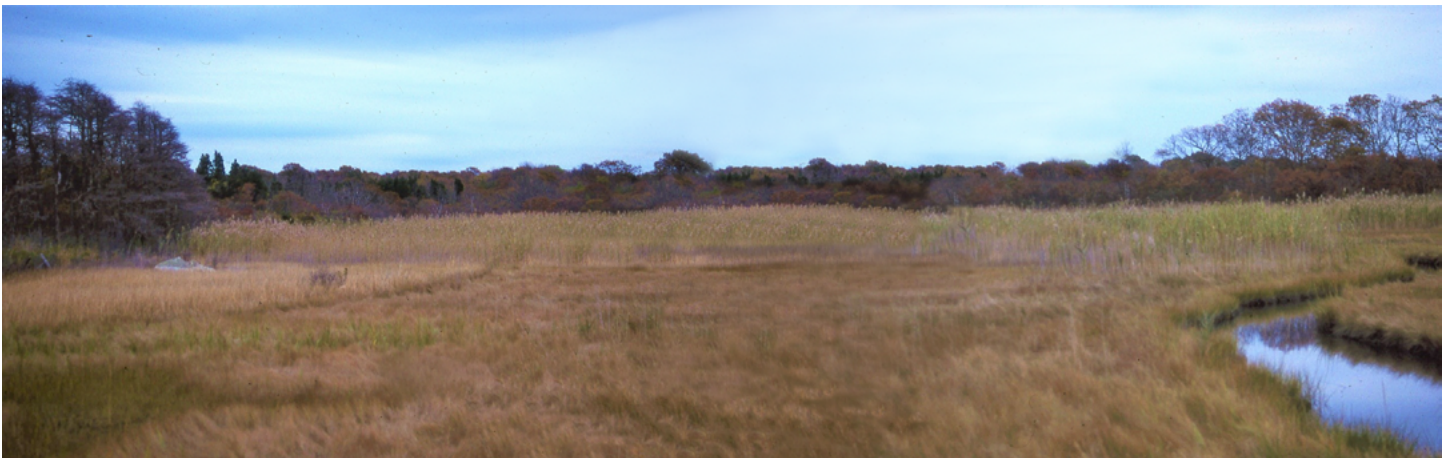
Figure 5. View of eastern section of Cow Yard Marsh on October 31, 1995, looking toward Plots 9 through 12. (R. Tiner photo)

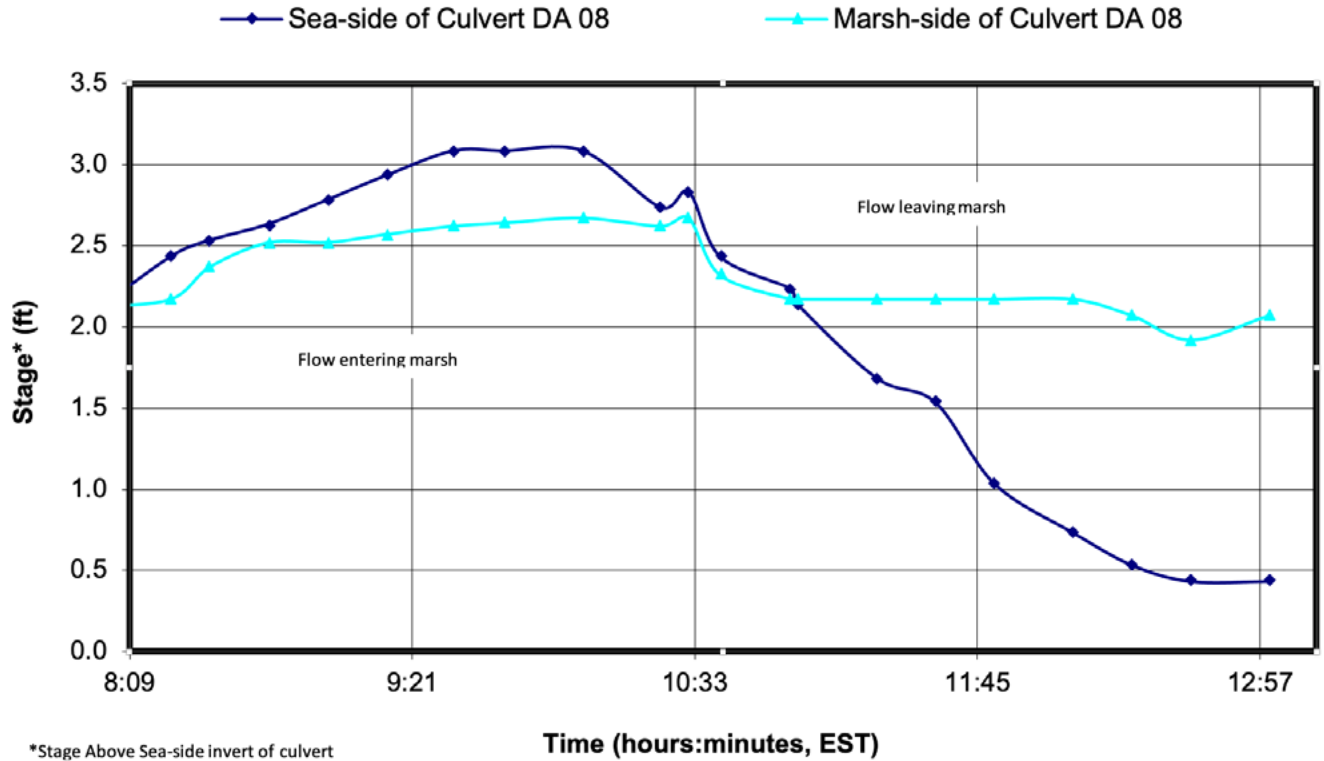
Figure 6. Tidal hydrograph showing water levels on both sides of the culvert connecting the lower marsh to Little River. (Source: Earth Tech 2001) At this point, the Dartmouth Conservation Commission secured cooperation and support from a number of public and NGO entities: Bristol County Mosquito Control, Dartmouth Natural Resources Trust, Buzzards Bay Coalition, Massachusetts Division of Ecological Restoration, and the Buzzards Bay National Estuary Program. With funding from the Fish America Program (NOAA Restoration Center) and DNRT, permitting was done to replace the 19" x 30" pipe with a 3' x 4' box culvert to increase tidal flow to the marsh complex. In March 2004, the box culvert was installed.

the expected height and that the outflow was also restricted producing a damming effect that failed to allow sufficient drawdown at low tide (Figure 6). Scouring at the culvert was also observed, providing further evidence of restriction – a 4.6 m (15-ft) wide scour depression on the marsh side of the culvert demonstrated restricted outflow. This reduced flushing would continue the retention of freshwater and maintain common reed, thereby limiting the re-establishment of salt marsh vegetation. There were minimal effects at the other culverts, so the focus of the restoration project would be on restoring full tidal flow via the marsh’s connection to Little River.

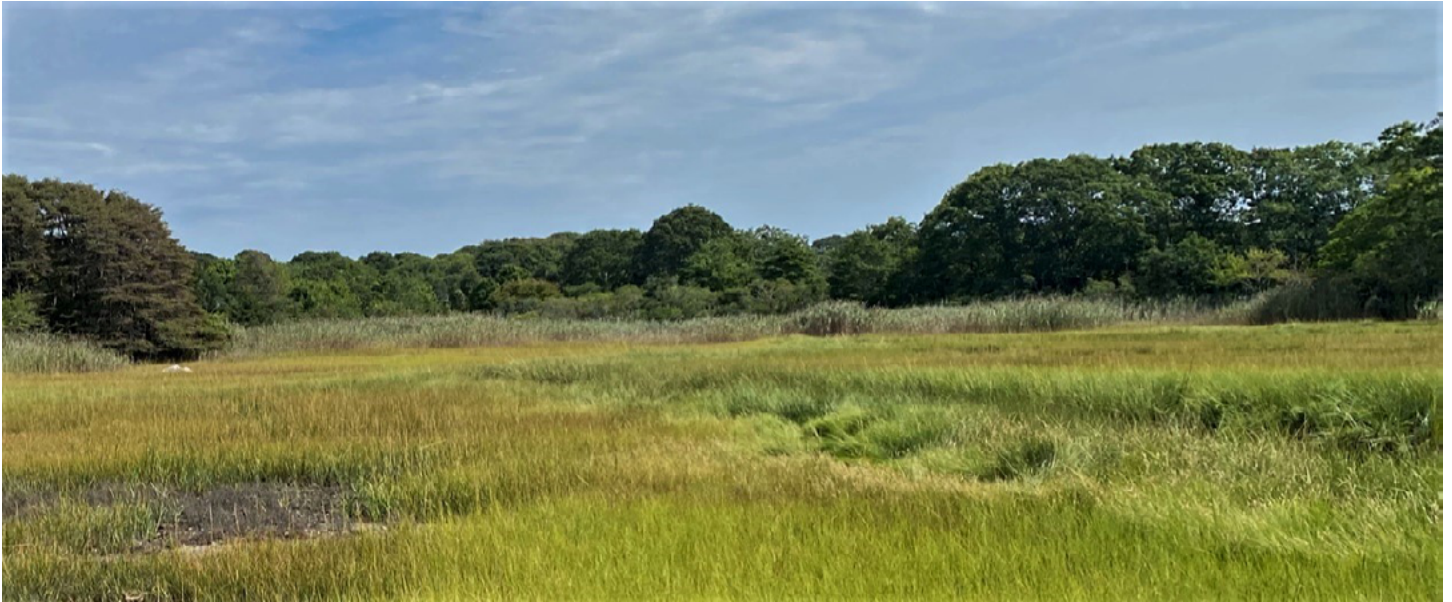
Figure 7. Panoramic view of same scene shown in Figure 5 as of October 2021. *Phragmites* has been pushed back to the east but remains where fresh water enters the marsh. (M. O'Reilly photo)

This restoration has allowed the marsh to follow vegetation patterns similar to other southern New England salt marshes where smooth cordgrass is becoming more abundant in former upper high marsh zones in response to rising sea-levels (e.g., Warren and Niering 1993; Donnelly and Bertness 2001). Figures 7 and 8 show what the marsh looks like today. Without question, the project was successful at bringing back salt marsh vegetation to portions of the lower unit that were invaded by common reed and pushing common reed back to the marsh fringes and where the stream empties into the marsh (Figure 9).

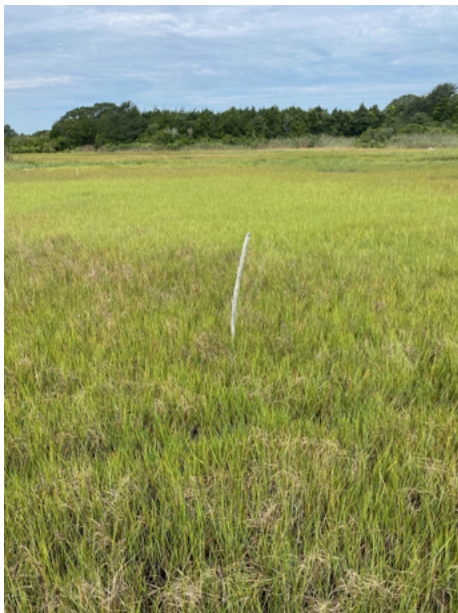
Figure 8. View of Plots 15A and B (stakes visible) looking northwest from Cow Yard Lane, in September 2021 – no *Phragmites*. (Note: This is the same area shown in Figure 4 but view is to northwest rather than to west.) (M. O'Reilly photo)

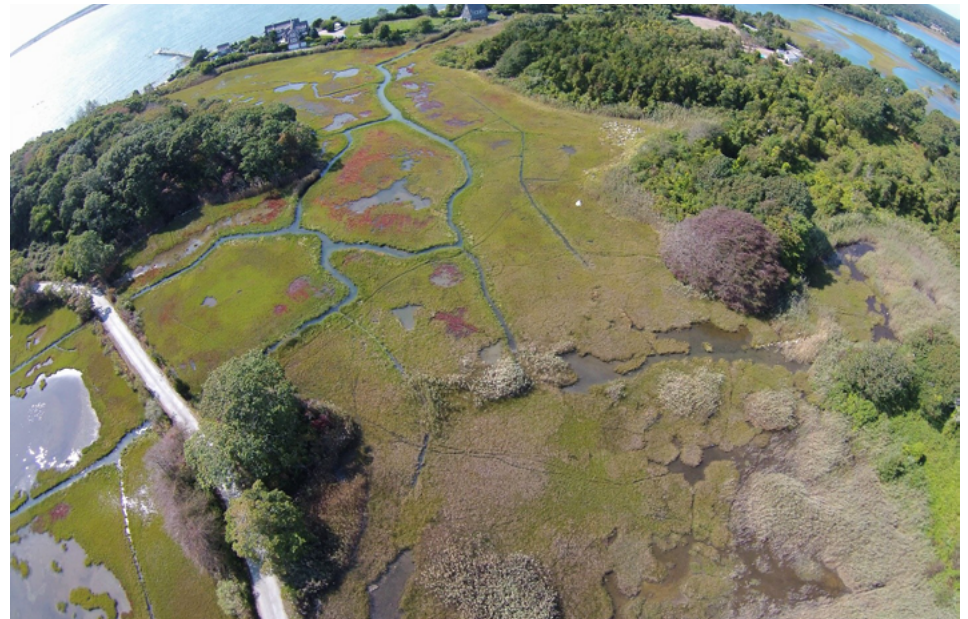
Figure 9. Aerial view of Cow Yard Marsh in the fall of 2021. A few scattered patches of *Phragmites* (coarse-textured whitish areas) remain in the eastern marsh unit with the most extensive reed marsh occurring along the woodland border (lower right). It also appears that there is some dieback of woody vegetation along the northern edge of the marsh (on middle right of image) plus an increase in the number of pannes dominated by glassworts (*Salicornia*; red areas) and pools (open water) when compared to a 2001 aerial photograph (Figure 10). (Source: Dartmouth Natural Resources Trust)

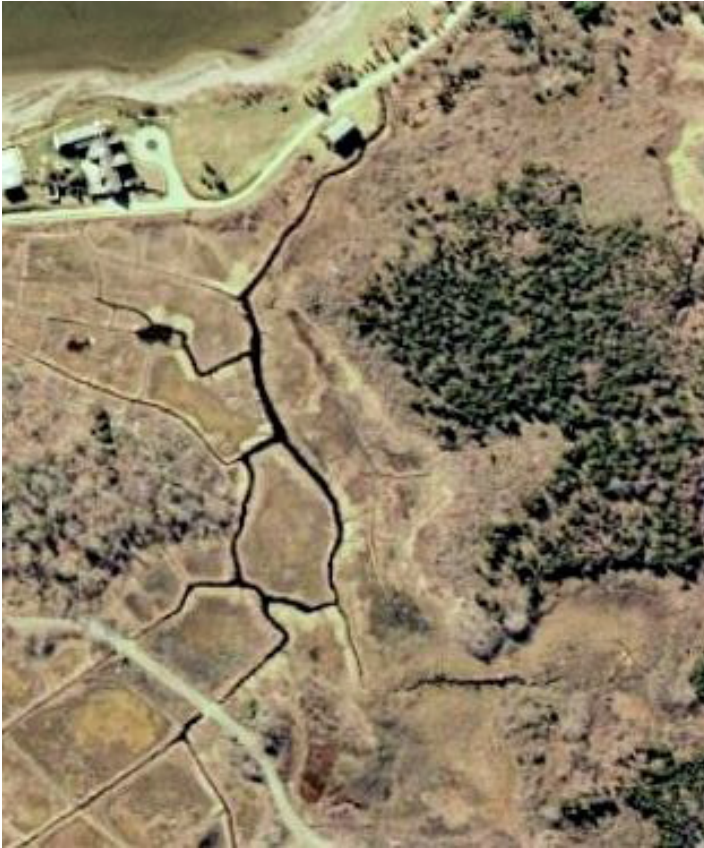
Figure 10. April 2001 image of the lower unit of Cow Yard Marsh. (Source: Mass GIS OLIVER)
