## Impact of Rapid Infiltration Beds on Hydrology, Vegetation and Chemistry of a Forested Wetland

Catherine Owen Koning<sup>1</sup>, Franklin Pierce University, Rindge NH; Jennifer Bell, Plymouth State University, Plymouth, NH

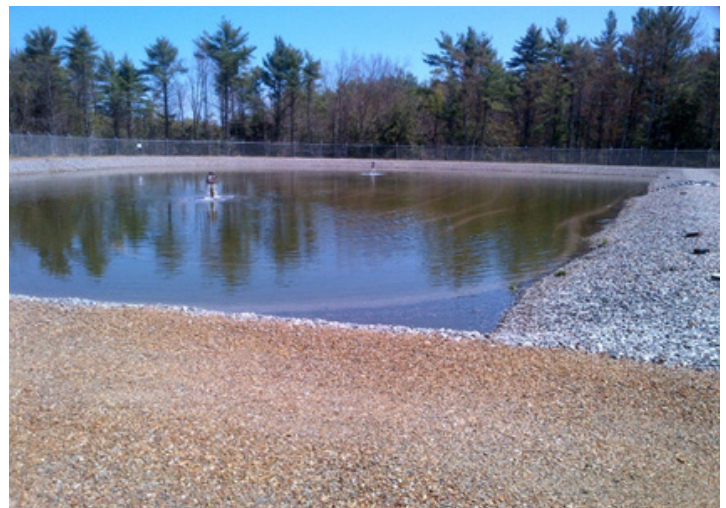
Figure 3. Franklin Pierce University Rapid Infiltration Bed, south basin.

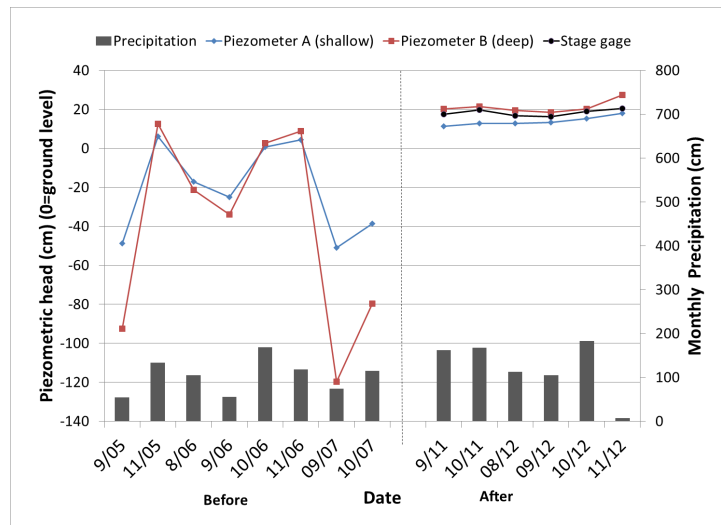
Figure 4. Wetland head levels in Piezometer A (shallow) and B (deep) before and after installation of the RIBs. Stage gage data were not available from the before period. Monthly precipitation is shown by the bars corresponding to the secondary axis.

Piezometric head levels in Piezometer A increased from an average of 37.24 cm (std. dev. 23.53 cm) below ground to an average of 13.96 cm (std. dev. 2.38 cm) above ground after installation (Figure 4). Similarly, levels in Piezometer B increased from an average of 42.11 cm (std. dev. 50.73 cm) below ground to an average of 21.2 cm (std. dev. 3.21

cm) above ground after installation. Annual discharge from the wastewater treatment plant did not change significantly, averaging 15.3 million gallons per year (std. dev. 0.23 MG/yr) in 2005-2007 and 15.7 (std. dev. 1.25 MG/yr) in 2011-2012. Stage gage data show high water levels, similar to those of the piezometers, in the period after RIB installation as well. Not only did head levels increase substantially, but there was far less variability in head levels in both the shallow and deep piezometers after the RIBs were installed, as indicated by the smaller standard deviation (Figure 5). Water levels increased sufficiently during the study period enough that a surface flow outlet that had rarely seen any outflow was observed to contain flow much more often. A change in precipitation could not explain this difference since annual precipitation was slightly lower in the years after installation (i.e., averaging 115.78 cm, std. dev. 26.7 cm compared to 121.9 cm, std. dev. 18.3 cm in the years before installation; Figure 4). The impact of this change in water levels on the wetland can be seen in Figures 5a and 5b.

Prior to installation, relative head levels in piezometers A and B indicated a pattern of weak recharge gradients in dry periods, alternating with weak discharge gradients in wetter periods. After installation of the RIBs, head levels were higher in Piezometer B than in Piezometer A, indicating a weak but consistent pattern of groundwater discharge gradients (Figure 4).

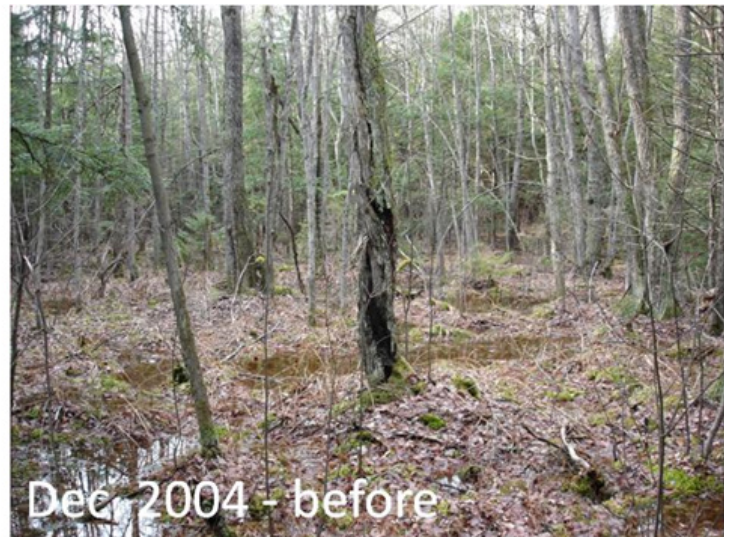
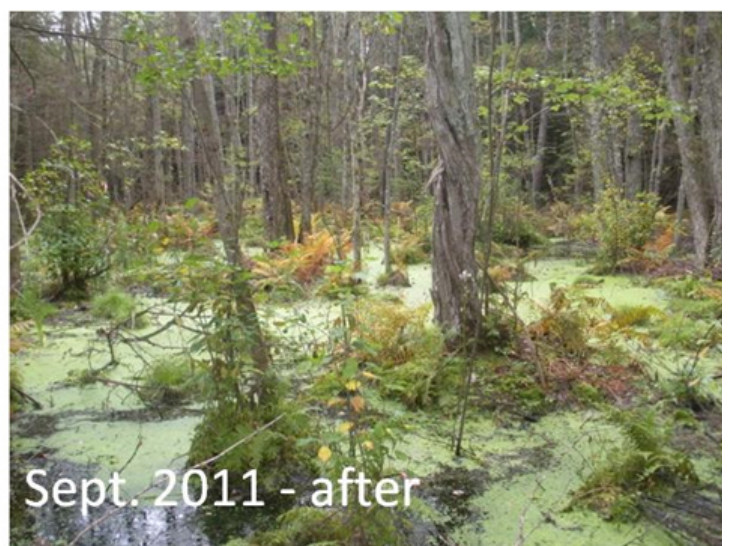
Figure 5. Wetland from same point before RIB installation and after. Note higher water levels after and the presence of duckweed, *Lemna minor* on the water's surface.

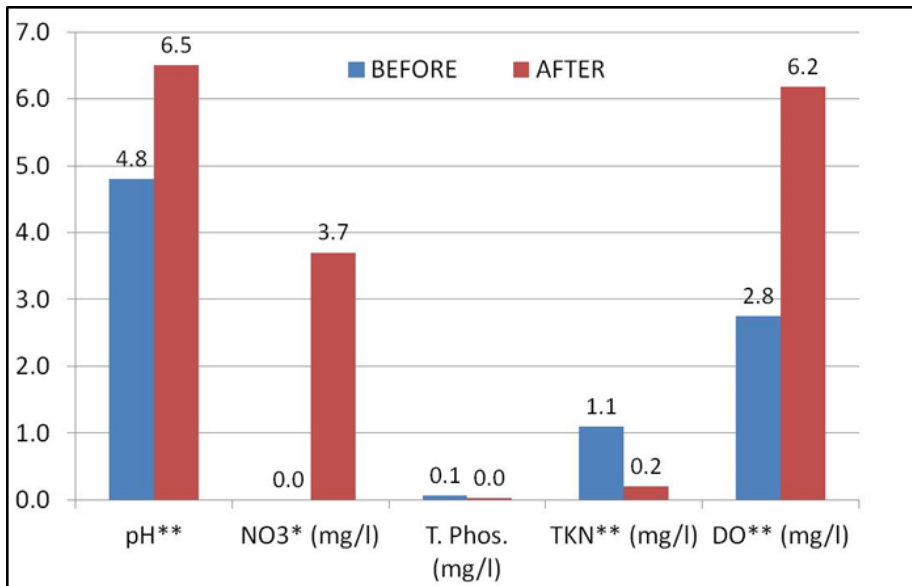
Figure 6. Water chemistry in surface water samples in adjacent wetland area before and after RIB installation. \*=significant difference at  $p < 0.01$ ; \*\*=significant difference at  $p < 0.001$ .

Surface water monitoring from 2006-2012 taken from an area 80 m southeast of this wetland for required monitoring shows a statistically significant increase in pH, nitrate, and dissolved oxygen, but a significant decrease in total Kjeldahl nitrogen and no significant difference in total phosphorus (Figure 6).

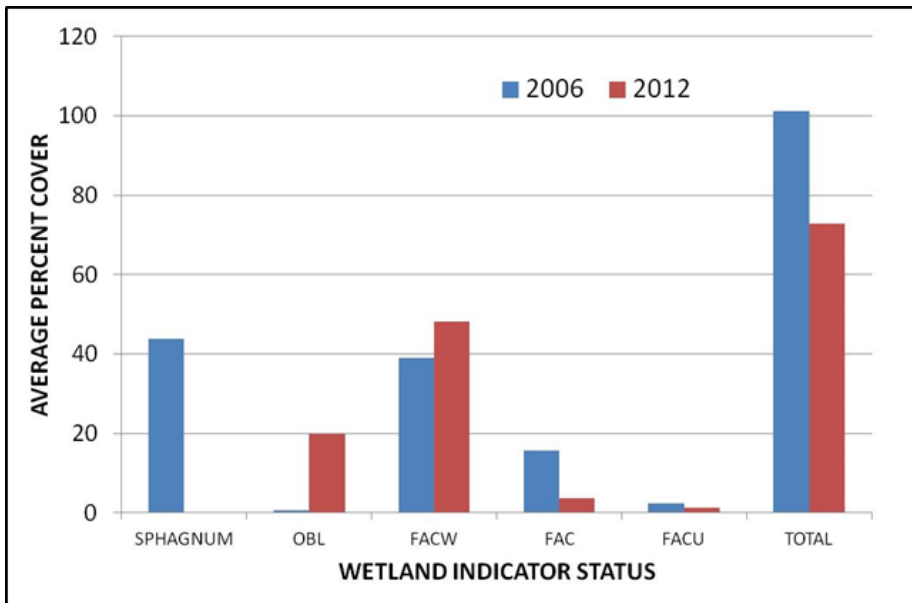
Figure 7. Wetland indicator status of plants in the wetland in 2006 (before RIB installation) and 2012 (after).

The wetland vegetation showed corresponding changes as well. As shown in Figure 7, the wetland was dominated by *Sphagnum* moss, facultative and facultative wetland species in 2006, but in 2012 the wetland is dominated by obligate and facultative wetland species, and the *Sphagnum* moss has been lost to inundation. The average vegetation cover in the wetland has decreased while dominance of obligate wetland plants has increased (vascular plants, excluding mosses). Table 1 lists new species that were observed after the RIB installation, including obligates *Typha latifolia* and *Lemna minor* and the invasive *Phragmites australis*. Further evidence of wetland degradation was the observation of many dead or dying trees of *Acer rubrum*, *Tsuga canadensis* and other species.
