Inaccurate Cover Classification Leads to Unnecessary Loss of Pennsylvania Palustrine Wetland Forest Structure and Functions

James A. Schmid¹, Schmid & Company, Inc., Media, PA

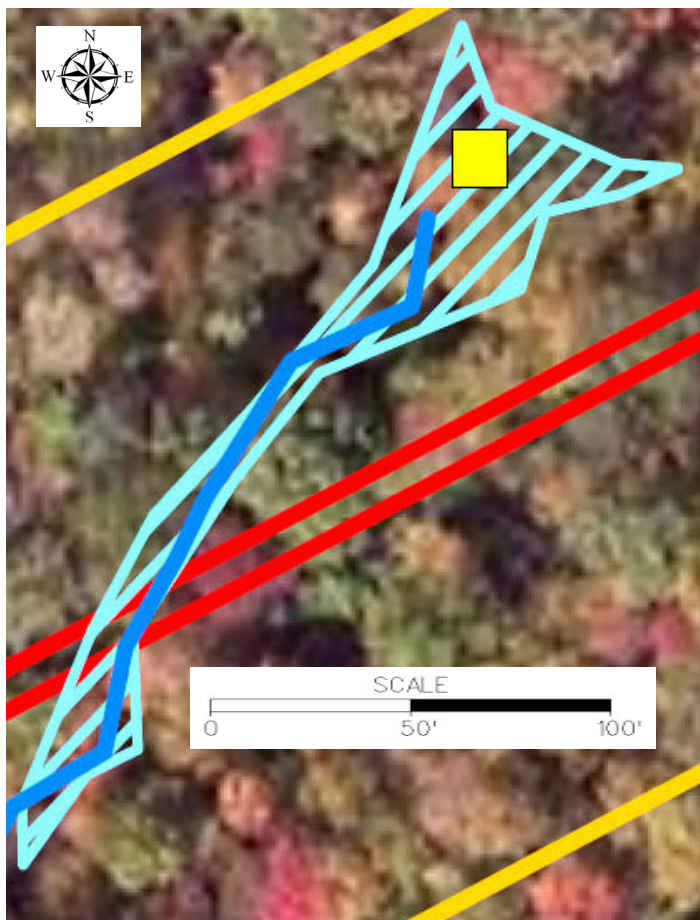
FIGURE 1. Obvious misclassification of forested wetland (pale blue stripes) along a partially identified perennial headwater stream (dark blue) in this excerpt from a July 2015 applicant aerial site plan drawing. Pale blue striped wetland polygon was recorded as palustrine emergent (PEM). Yellow lines show project study area limits; red lines are proposed new pipelines through the mature forest. Yellow box is applicant's wetland data log location for W-L24, where data in Figures 3 and 4 were recorded. The applicant's photobase, other aerial photos, and onsite observations (Figure 2) confirm the applicant's failure to record trees present at the sampling location. This airphoto apparently was taken circa autumn 2013.

Since no field flagging of wetland limits was provided by this applicant, boundary locations had to be reconstructed in the field from application graphics using global positioning system (GPS) and geographic information system (GIS) technology. When questioned regarding the apparent wetland misclassification identified in Figure 1, the consultant's response was that no rooted trees had been found in these "herbaceous" wetlands because no trees were listed on the Corps wetland data form completed at the sampling location (applicant's yellow box), and there was no need to check further¹⁰.

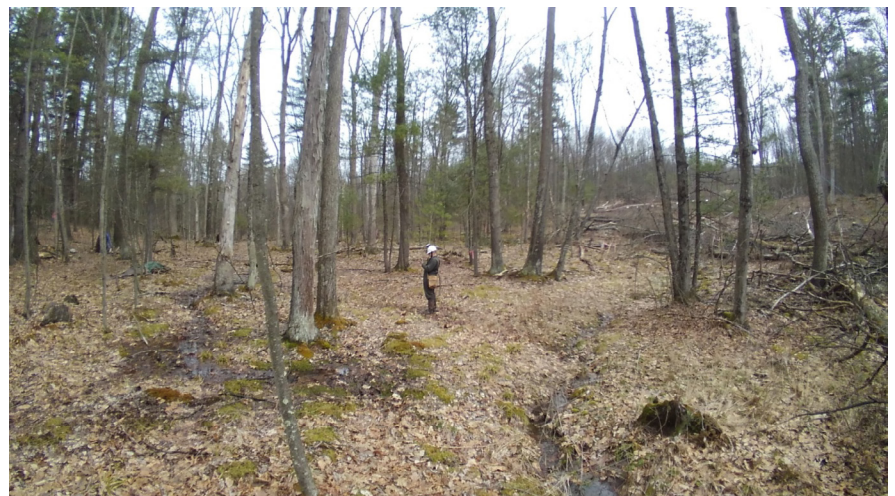
FIGURE 2. Man stands in the center of the applicant's recorded wetland sampling location, the yellow box for W-L24 shown in Figure 1. View northeast, April 2018. Recent clearing in background at right surrounds the area of red lines (proposed new pipelines) in Figure 1. Facultative hydrophytic trees (chiefly red maples, *Acer rubrum*) in fact are obviously rooted in this wetland. No trees were listed on the vegetation data form allegedly recorded here (Figure 4). Hence this wetland was erroneously reported as PEM and defended merely by reference to the erroneous data form.

Actual conditions at this sampling location are shown in Figure 2. The basic error was misrecording the plants present, and that became the "justification" for erroneous cover classification. The mapped location of this sampling station differed from its reported latitude and longitude coordinates by 21 m (68 feet), although agency reviewers did not notice the misrepresentation or that any alternative sampling location in this wetland was similarly forested. The applicant's accompanying stream data sheet S-L41 representing the proposed pipeline crossing of the stream within wetland W-L24 records the stream channel itself as having 50% tree cover (presumably external cover determined following the conventions of Barbour et al. 1999). Corrections were not made by the applicant or required by regulators, despite landowner protest. Because of misclassification, the intended permanent conversion of 0.027 ha (0.066 acre) of forested wetlands to herbaceous wetlands here was not acknowledged. That omission alone is 42% greater than the acknowledged conversion in the surrounding county and 16% of the entire acknowledged project total. No applicant plans show any proposed replanting of the riparian forest to be "temporarily" destroyed here during construction.

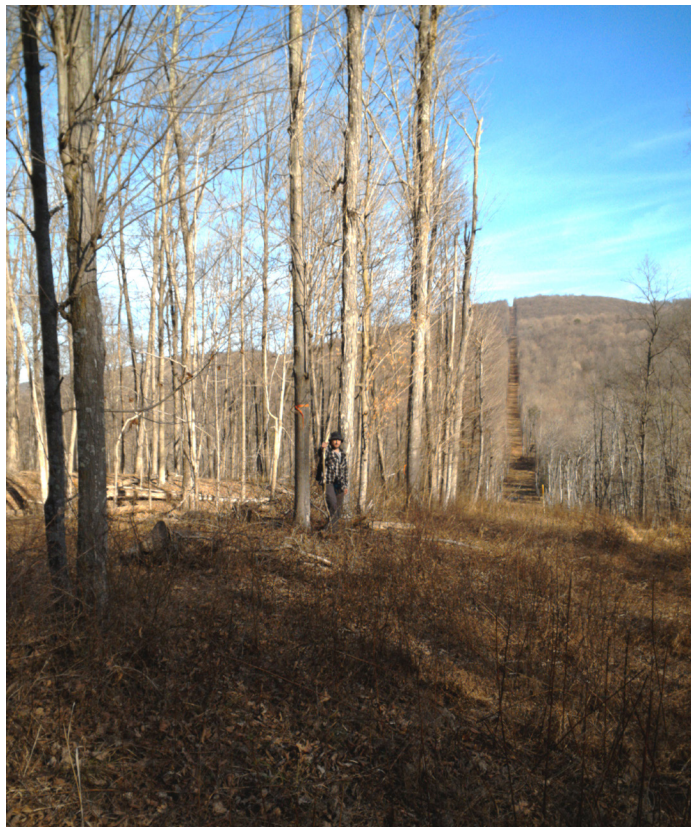
FIGURE 7. View east toward Schultz Ridge about 1.8 km (1.1 mile) distant, February 2017. PEM wetland (foreground at right) is in cleared right-of-way of existing pipeline with PFO wetland to north (left) mislabeled as PEM. The distribution of trees shown in the aerial photo (Figure 5) and by the applicant’s treeline in Figure 6 is confirmed as accurate by field inspection. Several applicant drawings claim that PEM extends for 15 m (50 feet) to the north (left of the man in photo), in contradiction to the applicant’s accurate tree canopy line on the north side of the existing pipeline corridor in Figure 6. Photo location is shown by horizontal arrow in Figure 5. Man stands in the same place along the tree line in Figures 7 and 8.

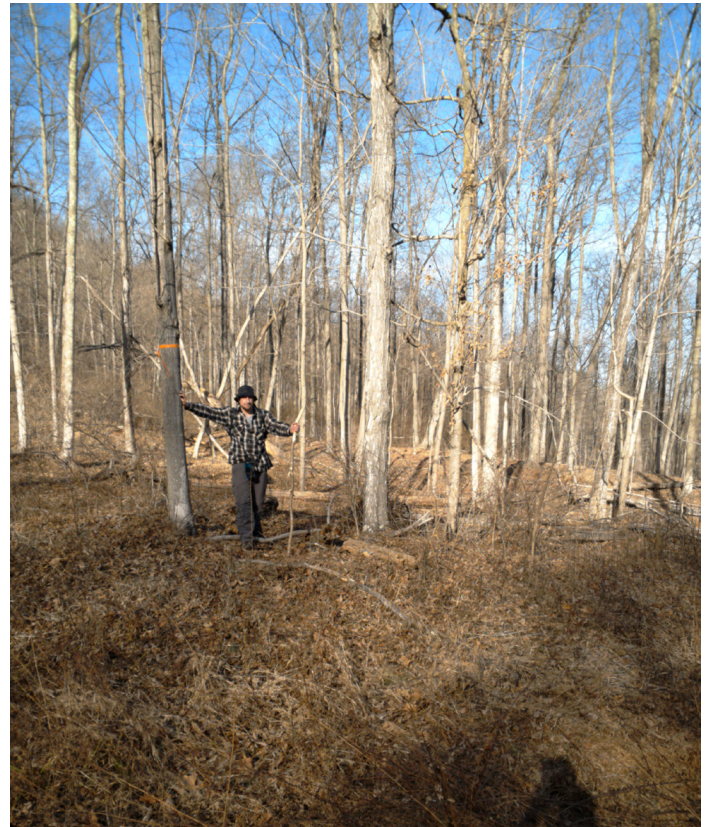
FIGURE 8. View north directly into mislabeled, red maple-dominated PFO wetland across foreground PEM wetland in the cleared right-of-way of the existing pipeline, February 2017. PFO extends northward through the alleged PEM and PSS wetlands here. All these trees subsequently were cut unnecessarily, and no proposed replanting of trees in “temporarily” disturbed sections of riparian forest is shown on applicant drawings. Photo location is depicted by the vertical black arrow in Figure 5. Man stands at same location as in Figure 7.
