Farmers in the Marsh: Lessons from History and Case Studies for the Future

Susan C. Adamowicz¹, Geoffrey Wilson², David M. Burdick³, Wenley Ferguson⁴, and Russell Hopping⁵

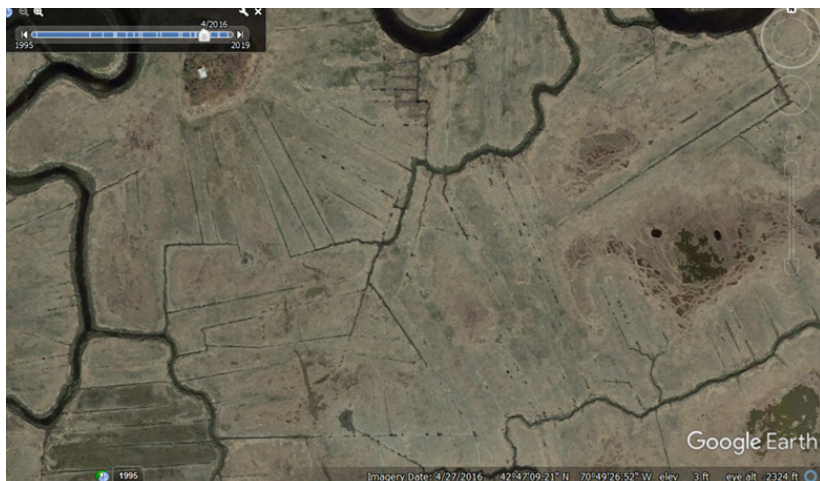
FIGURE 1. Aerial of Great Marsh, MA (April 2016) showing large number of small ditches. Little Pine Island is below the date bar. (Google Earth image accessed April 1, 2020.)

Staddles, circles of wooden posts driven into the high marsh platform, are one of the most iconic images of New England salt marshes. They were used by farmers to stack salt hay harvested from the immediate area; multiple staddles were present and common on most salt marshes. Martin Johnson Heade painted the haystacks atop the staddles during the second half of the 19th Century, decades before Monet painted his famous haystack series. Besides the staddles, the most commonly recognized remnant from salt hay farming are shallow, often closely spaced ditches (Sebold 1998; Figure 1).

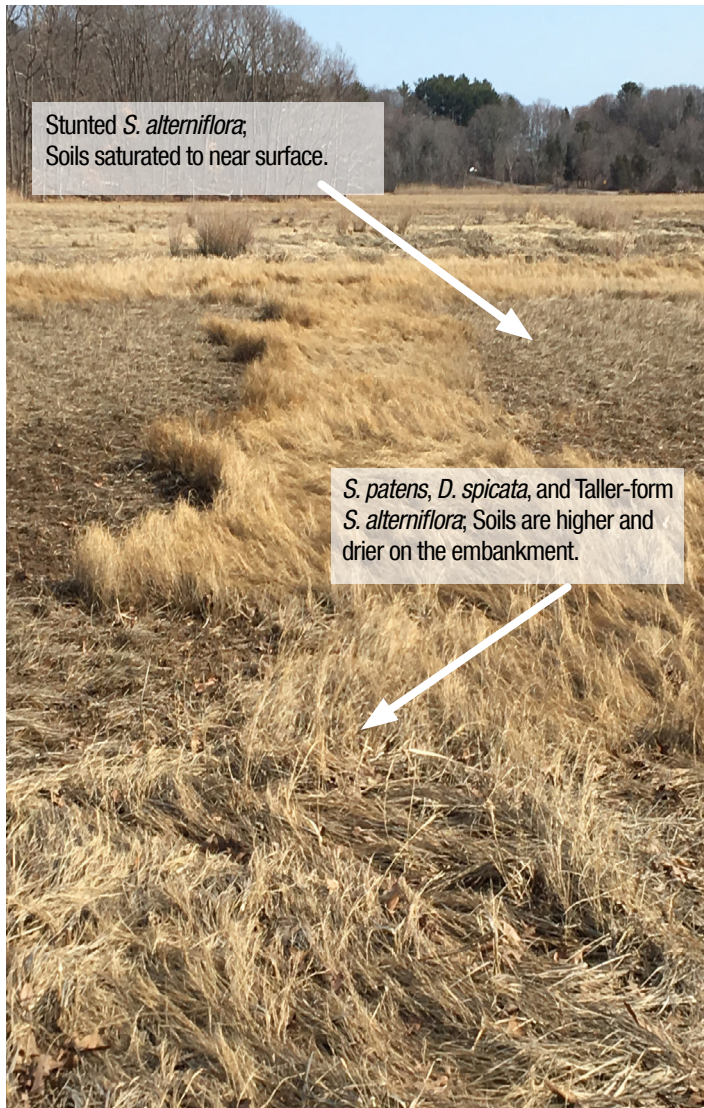
FIGURE 3. Remnant embankment at Old Town Hill, Newbury, Massachusetts. (Photo credit: G. Wilson.)

Stunted *S. alterniflora*,
Soils saturated to near surface.

S. patens, *D. spicata*, and Taller-form
S. alterniflora; Soils are higher and
drier on the embankment.

advent of Google Earth and other websites with historical aerial imagery, tax maps, deeds and other records have been vital tools in our current efforts to identify this farming infrastructure on salt marshes from Maine to the Carolinas. An important caveat, however, is that most of the embankments seen in U.S. salt marshes today are not the comparatively massive constructions common to Nova Scotia (Smith et al. 1989) that currently carry roads and highways, but are much more subtle features (Figure 3).

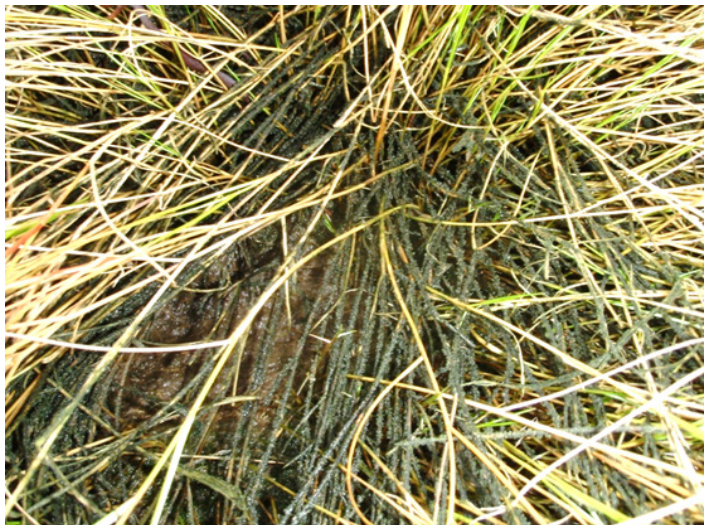
FIGURE 4. *Spartina patens* thatch with algae: 2010, Wells, Maine, USA. Notice bare ground visible below thatch layer. (Photo credit: S.C. Adamowicz.)

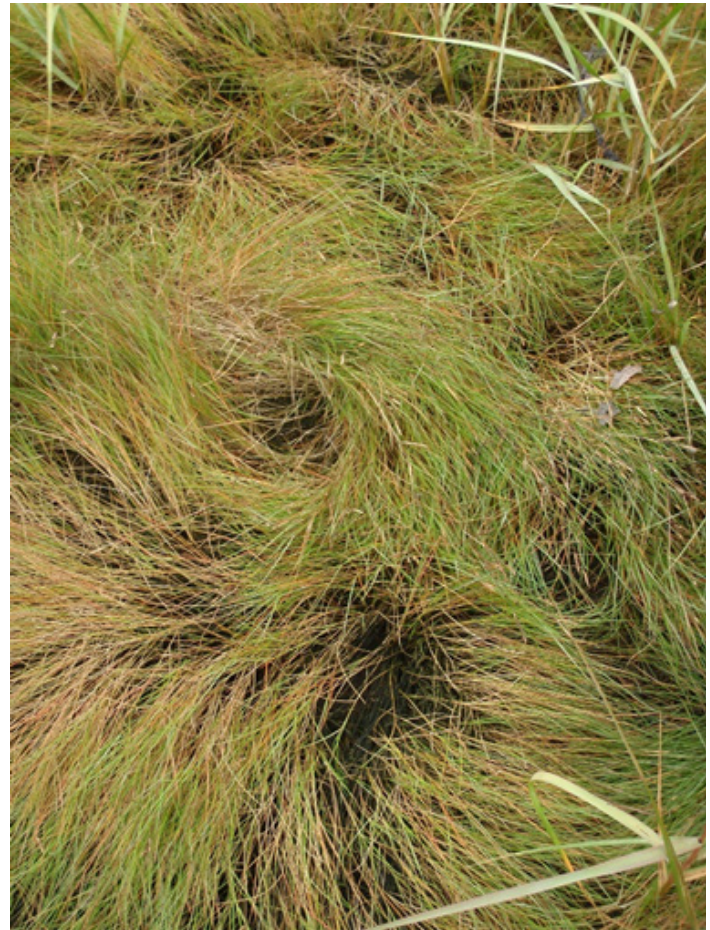
FIGURE 5. Encroachment of *S. alterniflora* into “high marsh” showing algae on thatch; 2010, Wells, ME, USA. (Photo credit: S.C. Adamowicz.)

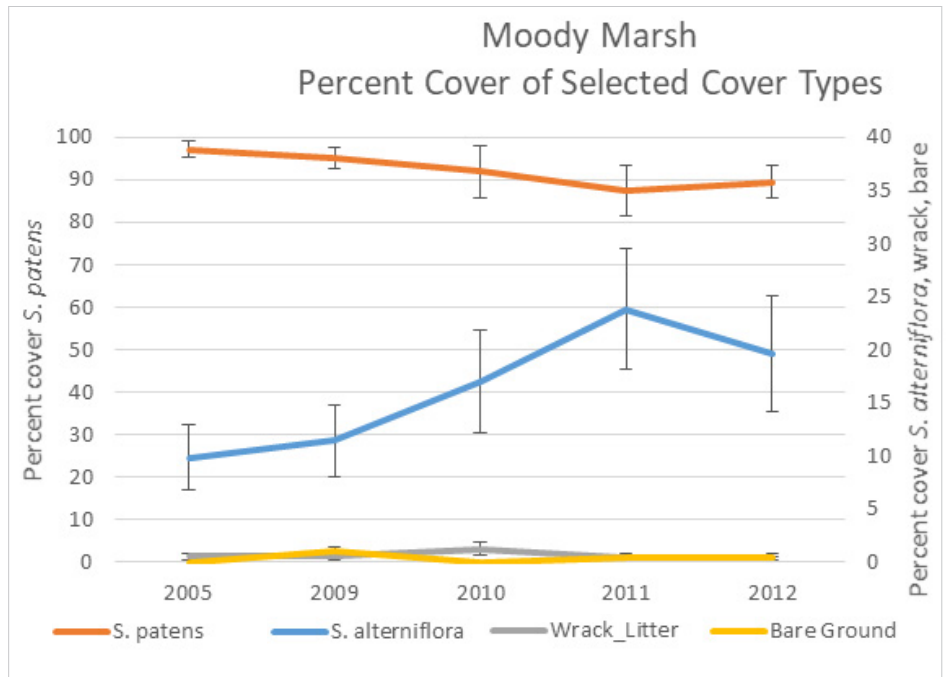
FIGURE 6. Decrease in *Spartina patens* (left axis) and increase in *Spartina alterniflora*, bare ground and wrack (right axis) indicate increased saturation at permanent plots in Wells, Maine (S. Adamowicz, unpublished data).

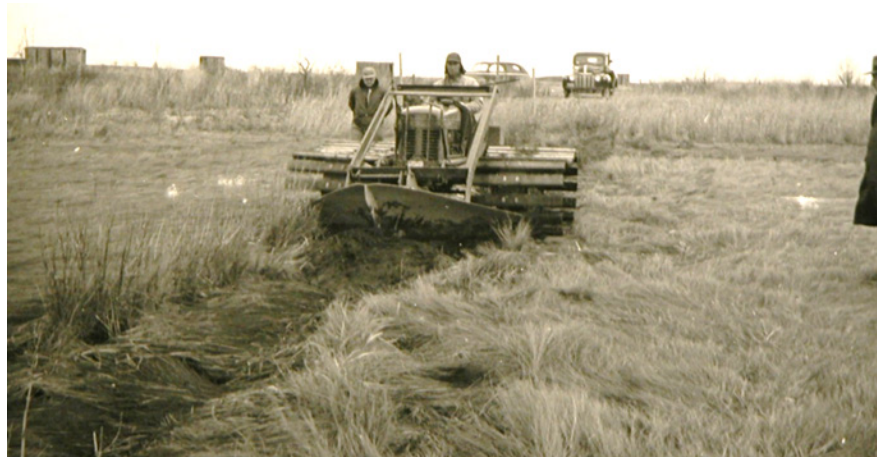
FIGURE 9. Scavel plow clearing debris from a mosquito control ditch circa 1940-1950s. Mechanized ditching patterns are ubiquitous from Massachusetts southward, often overlay previous agricultural ditching patterns, may not adhere to tideshed boundaries or original marsh slope, and develop highly compacted embankments on both sides of ditches. (Photo credit CT DEEP.)

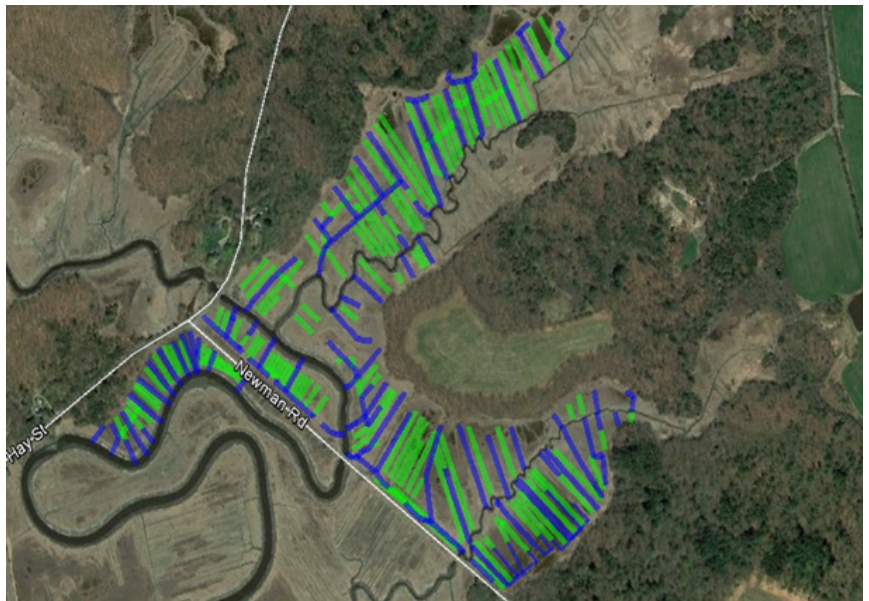
A.

FIGURE 10. Old Town Hill Reservation, Newbury, MA. A) 219 primary (blue) and secondary (green) ditches. B) 51 embankments (red) identified. (Google Earth accessed April 2018.)

Owned and managed by The Trustees of Reservations, this salt marsh lies in the upper part of the tidal range and is heavily ditched. After examining a series of historic aerial images and with field verification, Geoffrey Wilson determined there were 219 farmer's ditches and 51 agricultural embankments (Figure 10). A 1907 map of the area shows that virtually the entire property and surrounding landscape was cleared (The Trustees of Reservations 2007). The Hill was open with a watch house and a large elm growing on top that was used for navigation. Currently most of the marsh is on a subsidence trajectory. Large areas of marsh platform are saturated and support stunted (30 cm) *S. alterniflora* and *Distichlis spicata*; *S. patens* grows best on the many embankments.

Wilson's restoration design relies on identifying tidesheds and primary drainage channels in the field. These will be re-emphasized by using ditch remediation (Burdick et al. 2019) to "heal" auxiliary ditches from the bottom up. Nine blocked ditches will be cleared to reestablish primary channel drainage. Collapsed ditches will be opened as runnels and used to clear shallow impounded surface water (mega-pools) so that vegetation can recolonize. Any peat removed in runnel creation will be placed so as to create slightly higher microtopography suitable for potential saltmarsh sparrow nesting. These methods correspond to Tiers 1 and 2 noted below (under Timeline). Importantly, each Tier creates small- to large-scale SALS nesting habitat.

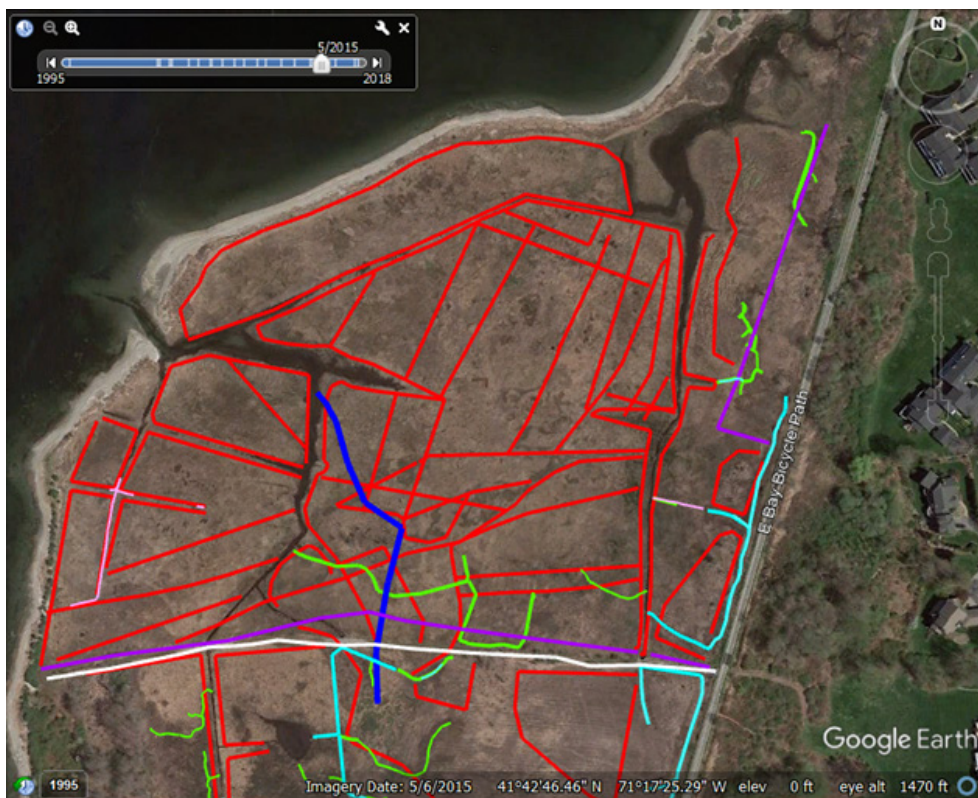
FIGURE 11. Jacob’s Point, Warren, RI, with runnels (light green), larger cleared channels (light blue), ditches (pink), embankments (red), stonewall embankments (purple), road/footpath (white), possible historic channel (dark blue) (Google Earth accessed May 19, 2020). All delineations were based on aerial signatures and need to be field verified.

Jacobs Point is managed by the Warren Land Conservation Trust and lies west of the East Bay Bicycle Path (a former railroad line) and just north of the Rhode Island Audubon Claire D. McIntosh Wildlife Refuge (Figure 11). This site is crossed by a 1915 road that is currently used as a footpath. An extensive patch of invasive *Phragmites australis* was controlled partially in 2010 through the replacement of three collapsed culverts under the footpath by partners including Save The Bay, U.S.D.A. Natural Resources Conservation Service, and the Town of Warren. Patches of *Phragmites* south of the footpath
