## Principles of Wetland Creation and Restoration: Reflections

### Part 2: Technology Transfer, Cross-over of Disciplinary Approaches, and the 1988 Burlington County (NJ) Case Study

Mallory N. Gilbert<sup>1</sup>, M.N. Gilbert Environmental, Troy, NY

**CASE STUDY 2. RIPARIAN CORRIDOR WETLAND CONSTRUCTION, ASSISCUNK CREEK, BURLINGTON COUNTY, NJ – 1986-1988**  
**Relevance of the Burlington County, New Jersey Case Study**

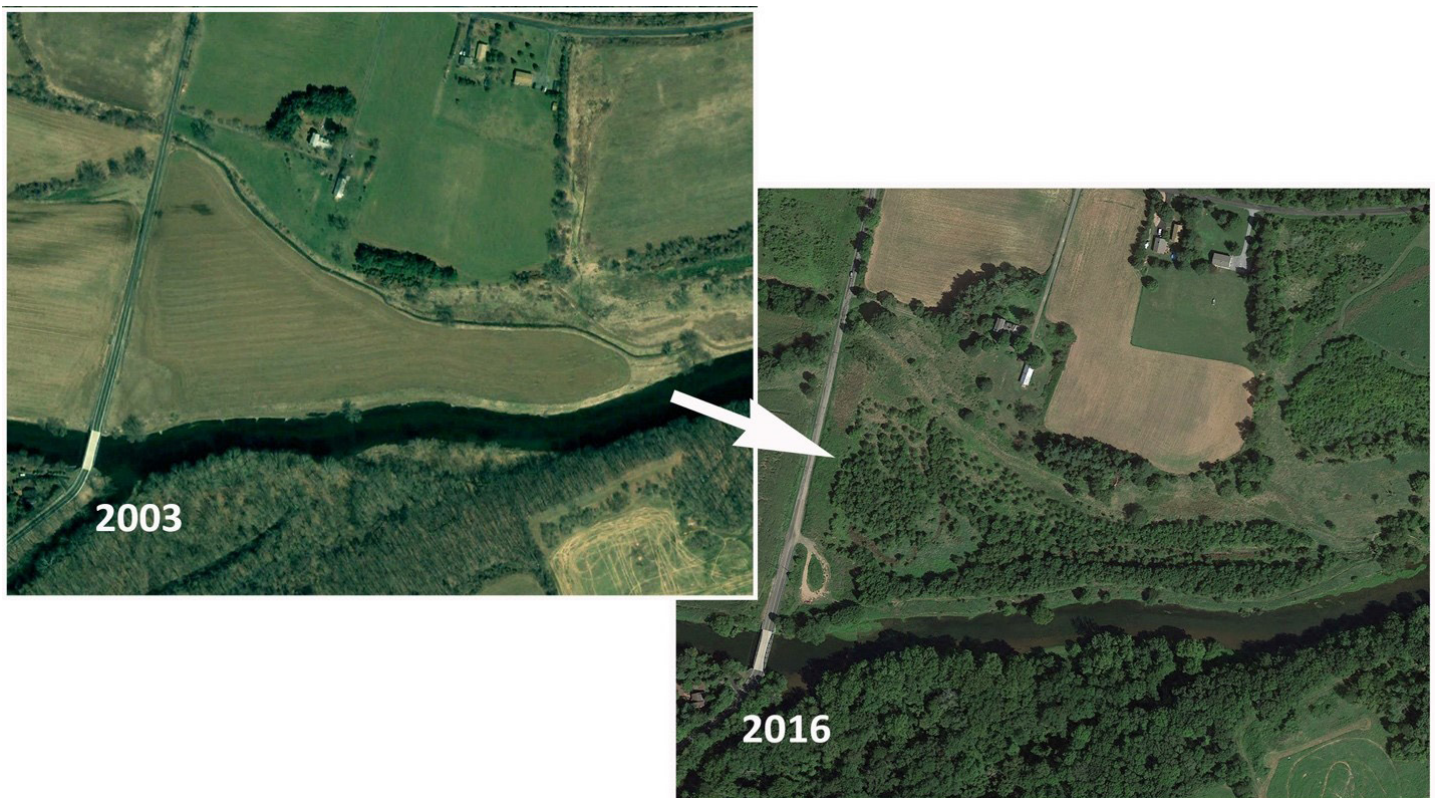
FIGURE 1. Aerial images of a floodplain mitigation site on the South Branch of the Raritan River in Neshanic, New Jersey. The vertical axis of each photo is North. No scale is provided, but the project area is  $\pm$  20-acres in size. The left image shows the Princeton Hydro site mentioned below as seen on May 5, 2003, prior to earthmoving, grading and replanting. Right image shows the site on August 27, 2016. A challenge for success of this project was prediction of periodic flooding from the adjacent small tributary along the northern limit of the project area as well as prediction of larger-scale flooding and backwater events driven by the whole of the riparian corridor watershed charging the main channel of the river.

Figures 2-5 that follow are printed with permission of Princeton Hydro, LLC of Ringoes, New Jersey. These figures illustrate how modern floodway modeling on one of Princeton Hydro’s wetland mitigation project sites allowed the designers to visualize stream reaches in two and three dimensions and predict how and when a riparian corridor wetland creation and enhanced flood water storage project site would be incrementally inundated. These few figures are offered as just one example of the value-added when we engage persons with expertise in other disciplinary silos and also to illustrate how innovations and advances have improved predictable outcomes for contemporary projects.

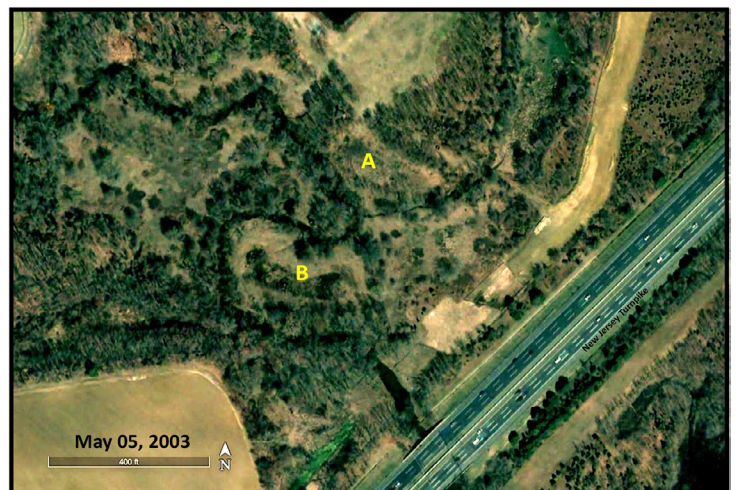
FIGURE 9. The constructed wetlands are seen more easily in this early spring 2003 aerial image.

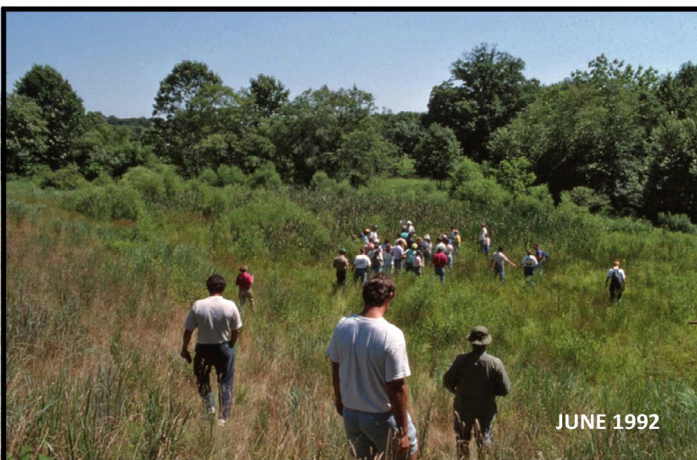
FIGURE 11. Fieldtrip students from Rutgers’ freshwater wetlands construction course entering Area “A” approximately four years after planting. A seepage area was encountered when the hillside on which the students are walking was cut away to create the wetland floor. By keeping much of the substrate saturated throughout the growing season, this persistent groundwater discharge had a profound effect on the development of the wetland.

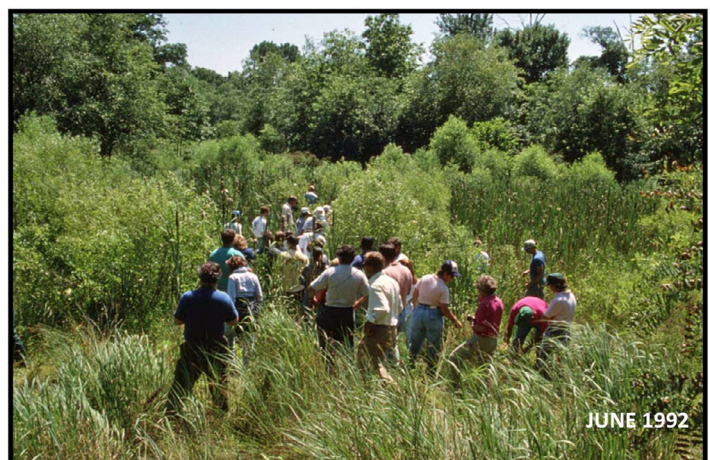
FIGURE 12. After observing the Wetland A slope seepage area and the emergent portion of the site (Figure 11), students are seen moving into and through the scrub-shrub fringe of Wetland A enroute to Wetland B.

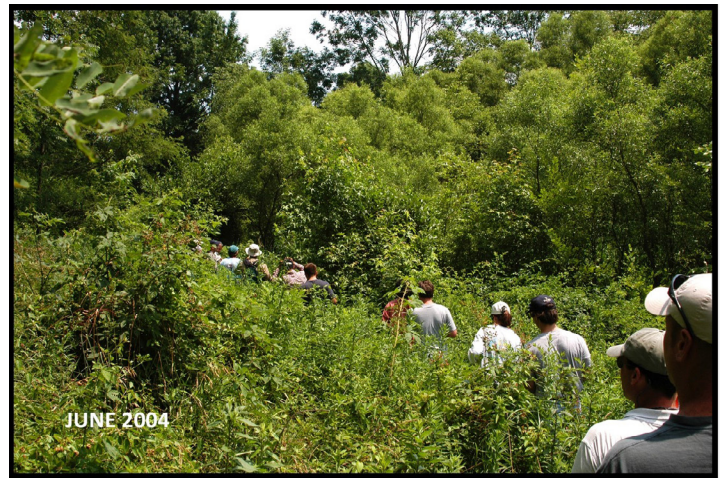
FIGURE 13. Another group of fieldtrip students entering Wetland A approximately sixteen years after planting. The transition from an emergent/scrub-shrub plant community to a young forested wetland was well underway for the entire project area as early as 2001.

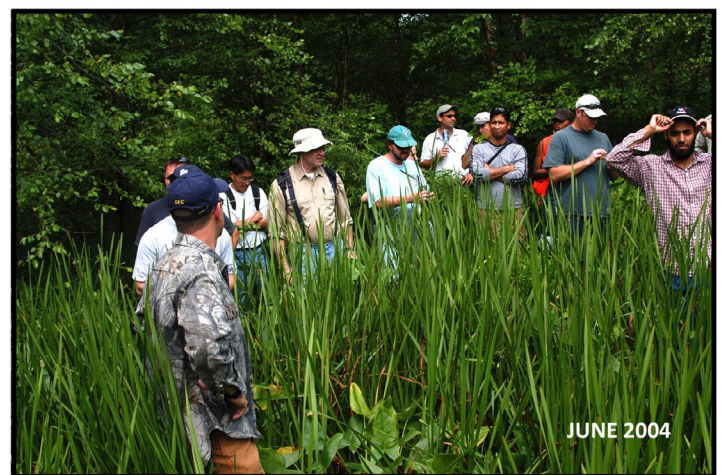
FIGURE 14. Dense emergent growth dominated Wetland B for a decade after its initial planting. However, by 2004, planted river birch (*Betula nigra*), silky dogwood (*Cornus amomum*), buttonbush (*Cephalanthus occidentalis*), and black willow (*Salix nigra*) had encroached and encircled the emergent center of the basin. Bur-reed (*Sparganium eurycarpum*), arrow arum (*Peltandra virginica*), duck potato (*Sagittaria latifolia*), smartweeds (*Persicaria* spp./*Polygonum* spp.), rice cutgrass (*Leersia oryzoides*), tussock sedge (*Carex stricta*), and an occasional cow-lily (*Nuphar luteum*) persist as emergent species in this 2004 photo.

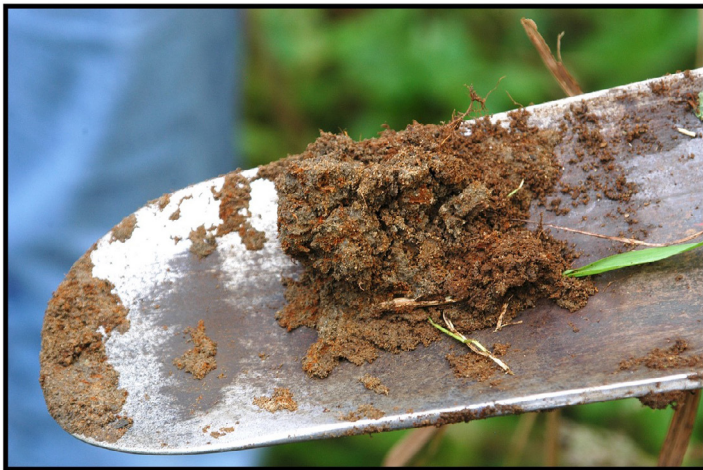
FIGURE 15. Hydric soil morphology was documented in both constructed wetland basins within 3 years following establishment. The sample shown here was removed on fringes of Wetland B at a depth of approximately 10-15 cm from the soil surface and is from a horizon located immediately below a 1-2 cm thick surface fibric organic layer (an Oi horizon). It has a coarse sandy loam texture and easily meets Hydric Soil Indicator F3 (Depleted Matrix). The high percentage of the redoximorphic concentrations and oxidized rhizospheres is evidence of the alternating oxygenated and anoxic aquatic conditions common in these frequently flooded soils.

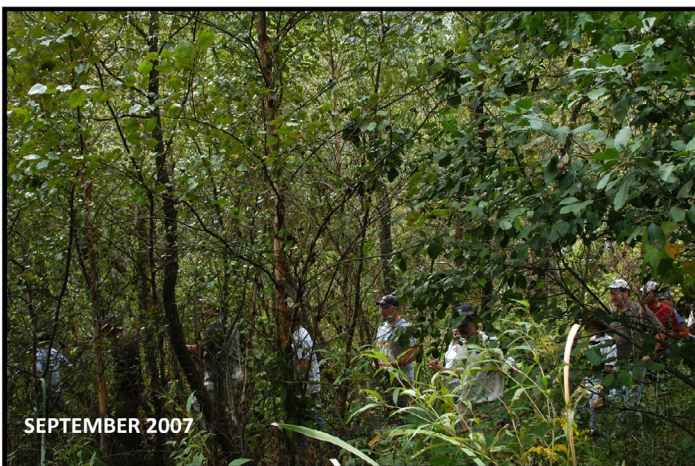
FIGURE 16. Fieldtrip students entering the forested portion of constructed Wetland A nineteen-years after planting. Spicebush (*Lindera benzoin*), river birch, buttonbush, and black willow are the dominant woody plants. At this developmental stage, the site had clearly met the criteria for classification as a Palustrine Forested (PFO) wetland.

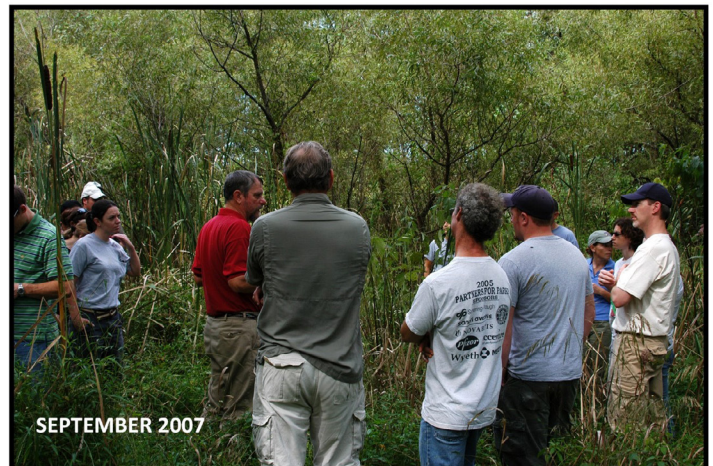
FIGURE 17. Under a closed canopy of river birch and black willow, Gary Pierce (red shirt) shares observations regarding transition of vegetation cover in Wetland A during the first twenty-years of development. Understory species include duck potato, halfbred-leaved tearthumb (*Polygonum arifolium*), arrowleaf tearthumb (*P. sagittatum*), wood reedgrass (*Cinna arundinacea*), rice cutgrass (*Leersia oryzoides*), remnant cattail (*Typha latifolia*), arrow arum, swamp rose-mallow (*Hibiscus moscheutos*), buttonbush, and sapling willows.

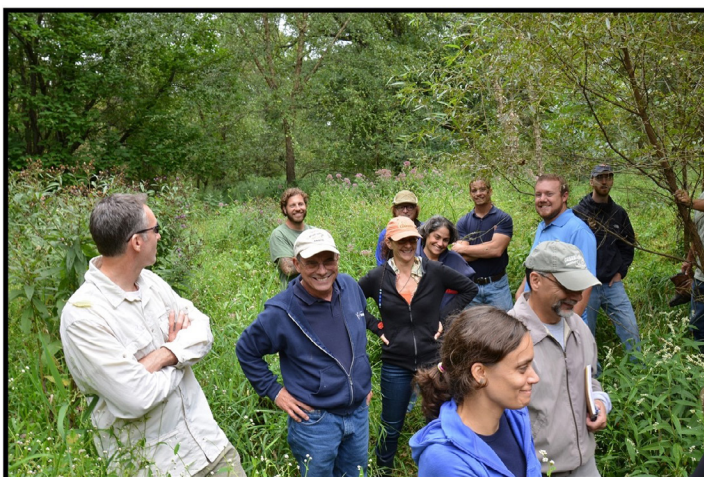
FIGURE 18. Field trip students on the fringes of Wetland B in September 2015. At this stage, the constructed wetland had blended into the natural physiognomy of the riparian corridor to a point where it is difficult to distinguish it from natural wetland depressions. Photographer’s vantage point was from atop a 3-foot wide, 2-foot tall tussock sedge.

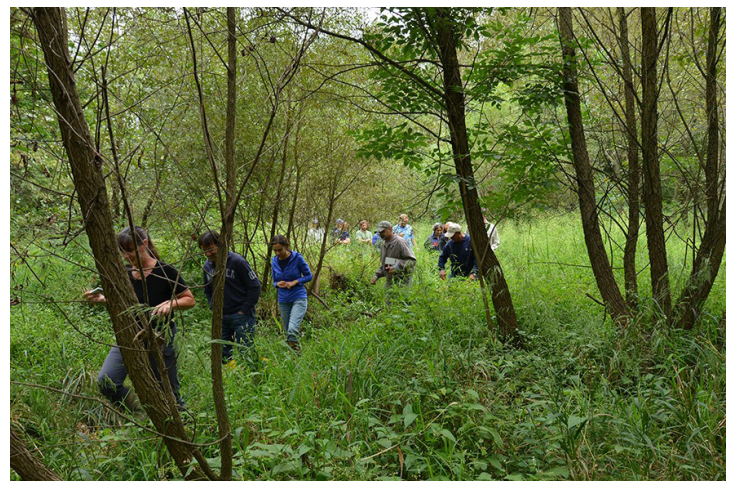
FIGURE 19. Students leaving Wetland B in September 2015. Students at left are walking along the earthen outlet fashioned twenty-six years earlier circa 1989. This outlet “channel” also allows waters from the adjacent stream to back into and then flow out of the wetland depression more gently as flood waters rise and fall in the riparian corridor.

tion of springtime hydrology, but shortly after planting, Dr. Pierce also installed an earthen outlet channel for Basin B to provide a more reliable fixed elevation to control maximum water depth (when not flooded) that would also allow more predictable vegetation zonation in the basin footprint. **Project Initiated:** Circa 1987; wetland construction completed – June 1988.

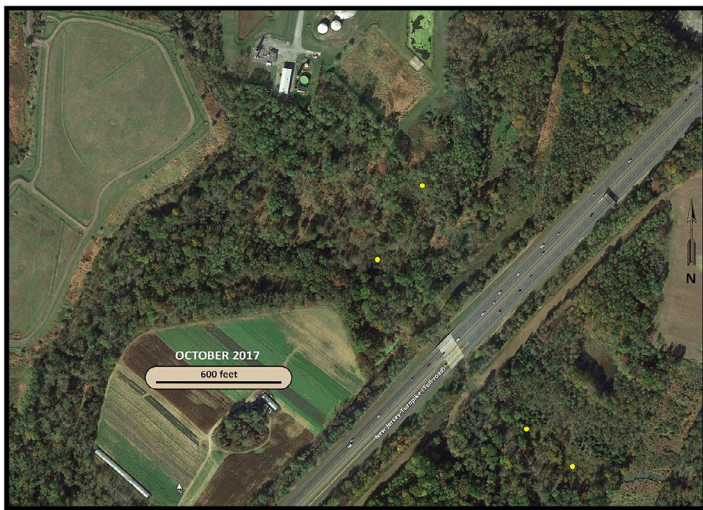
FIGURE 20. The wetlands constructed in the Assiscunk riparian corridor do not have complex or complicated water control structures and fit well into the surrounding landscape. Having been in place for nearly 30 years and now supporting a predominance of native species common in the riparian corridor, the constructed wetlands are nearly impossible to distinguish from other “natural” wetland depressions found within and along the stream corridor floodplain. Yellow dots pin-point four areas of constructed wetlands built between 1988 and 1993; the two upper ones are the subject of this article.
