Lessons Learned from the Finderne Mitigation Site, Bridgewater, NJ

Roy C. Messaros¹, U.S. Army Corps of Engineers, New York District

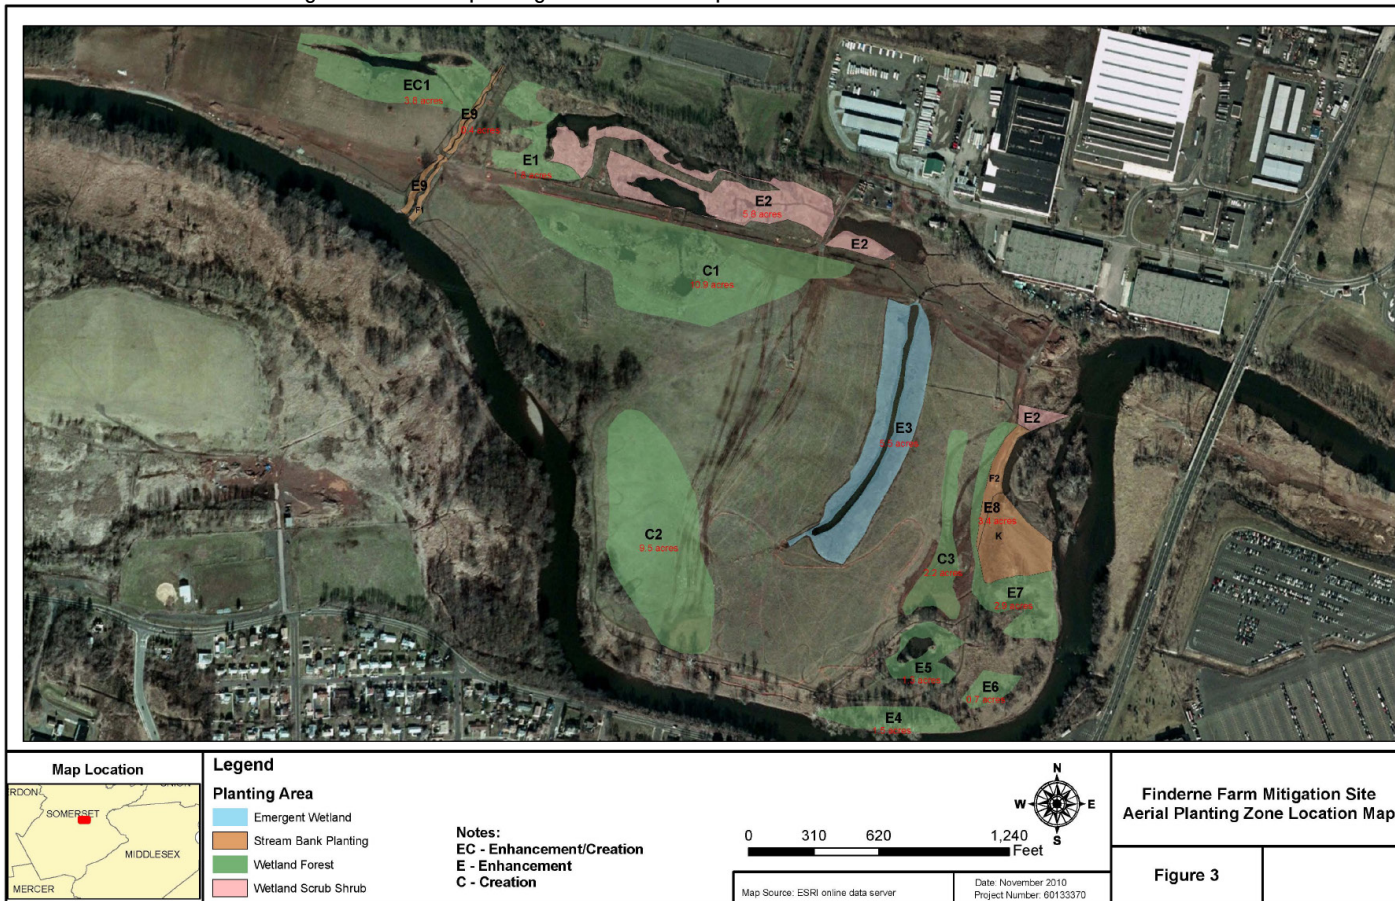
FIGURE 2. FINDERNE FARMS mitigation site aerial planting zone location map.

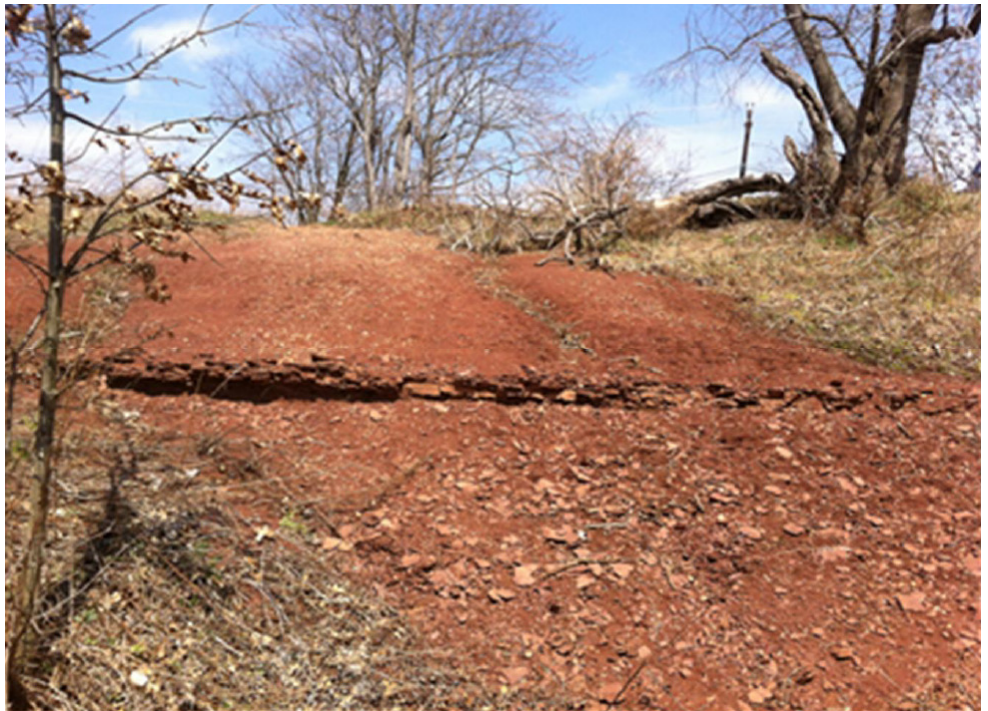
FIGURE 3. Outcrop of red-brown siltstone and mudstone (shale) at the FINDERNE Farms mitigation site.

Most of the Site consists of alluvial fine-grained deposits overlying red-brown siltstone and mudstone (shale) of the Jurassic-Triassic aged Passaic Formation (USACE 2014). Lithic material is limited to gravel material along the Raritan River bank, while the only rock outcrops on Site were observed within the slope that borders the northern side of the Site (Figure 3). Red lithic materials of the Passaic Formation are also exposed in northern portion of FINDERNE Brook, a tributary to the Raritan River on the northwest end of the Site. The Passaic Formation underlies the entire project area. Soils primarily consist of Rowland silt loam. Rowland soils are described as “very deep, moderately well drained to somewhat poorly drained soils formed in alluvial sediments weathered from red and brown shale, sandstone, and conglomerate” (https://soilseries.sc.egov.usda.gov/OSD_Docs/R/ROWLAND.html). The water table “fluctuates between 2 and 6 feet” and the soils are “flooded by streams during wet periods.”

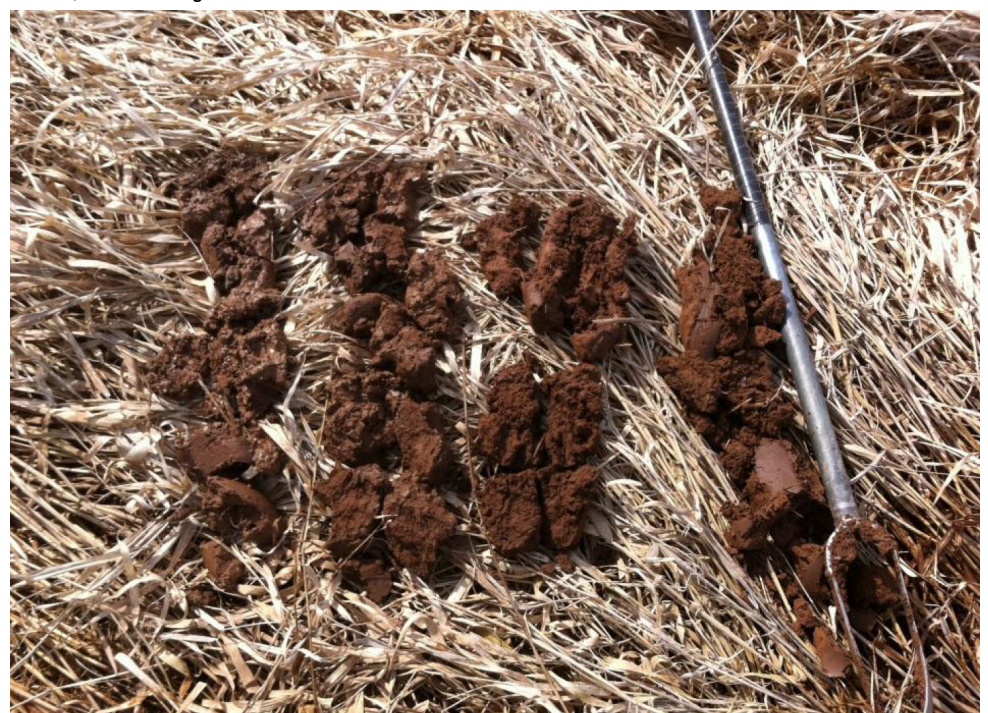
FIGURE 4. View of soil profiles taken from Creation Area C1, from left to right, C1-Ditch, C1-RCG, C1-SG, and C1-Mugwort.

in the various communities and identifying the presence or absence of hydric features in the soil profiles. Figure 4 shows the soil cores from the ditch (C1-Ditch), reed canary grass (C1-RCG), switchgrass (C1-SG), and mugwort (C1-Mugwort). Although often obscured by red parent material, redoximorphic features were observed in the ditch, reed canary grass, and switchgrass soil cores. The delineated wetland line often corresponded with the toe-of-slope of the created cut-slopes surrounding the wetland. Uplands adjacent to C1 wetlands were elevated 0.30 m or more above C1 and were dominated by common mugwort along the perimeter. Upland soils were observed to be similar to wetlands however with fewer (e.g., $\geq 50\%$ fewer) redoximorphic concentrations. The upland soils were also loose and friable and showed no evidence of saturation or inundation. The wetland classification system developed by Cowardin et al. (1979) was utilized to classify the delineated wetland vegetated community as palustrine emergent wetland (PEM). Table 5 is a summary of the data for Creation Area C1 showing the results from the hydrology, vegetation, and soil evaluations.

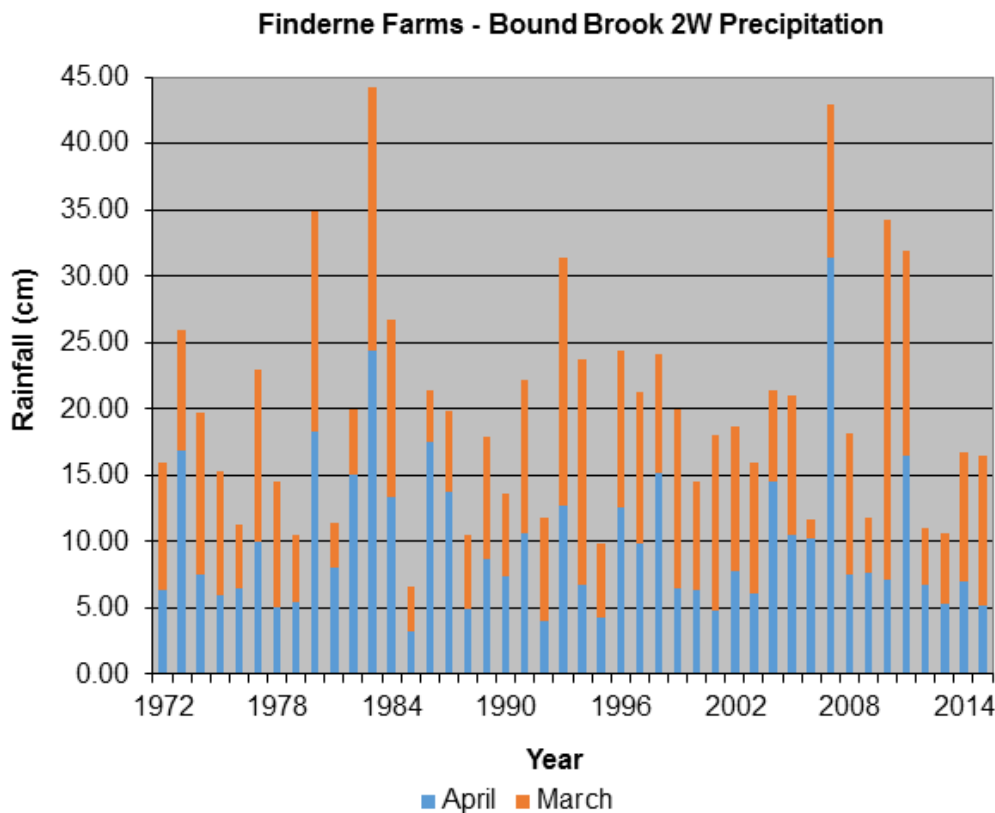
FIGURE 5. Total rainfall (cm) for March and April from 1972 to 2015. Note that average rainfall during March and April in these years was 19.74 cm, so rainfall during these months in 2014 was below average.

Wetland Delineation Report dated June 15, 2014 (USACE 2014) showed sufficient indicators of wetland hydrology during the more than two-week field investigation it may safely be implied that wetland hydrology likely occurred from 2007 to 2012. Figure 5 is a plot of the historic rainfall data illustrating the total rainfall (cm) for March and April (combined) for 1972 to 2015. As mentioned above, the frequency of Raritan River overbank inundation did not have a measurable benefit to the water budget as was originally anticipated. A valuable lesson learned is that adequately quantifying the temporal aspects of rainfall and understanding long-term conditions can be important to the planning a water budget for any wetland creation project.
