Unique Solutions for Building Envelope Repair

Rachel Michelin, AIA, LEED AP BD+C

Thornton Tomasetti

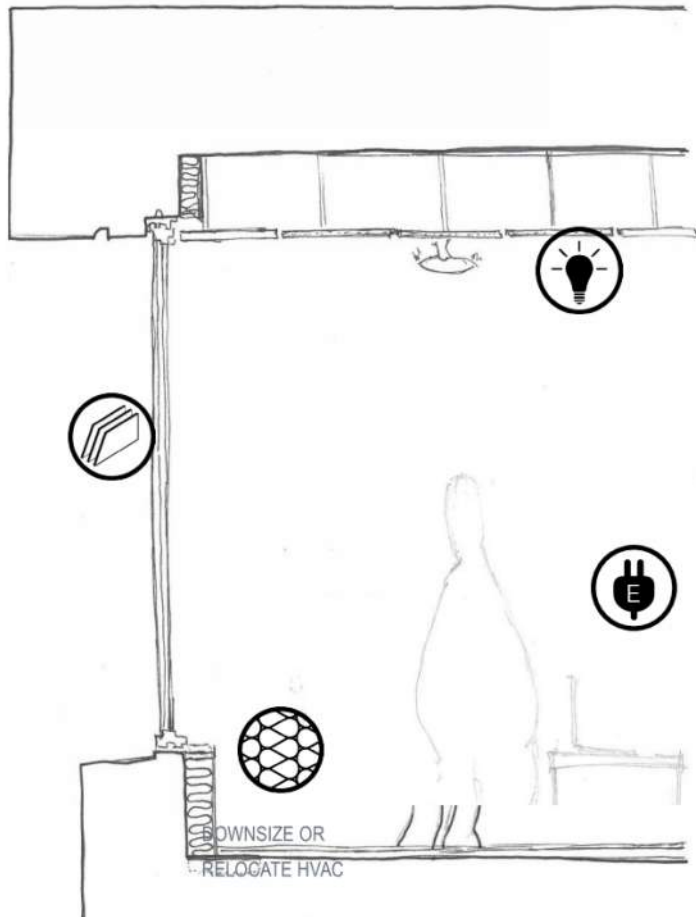
- Option 1: Retrofit

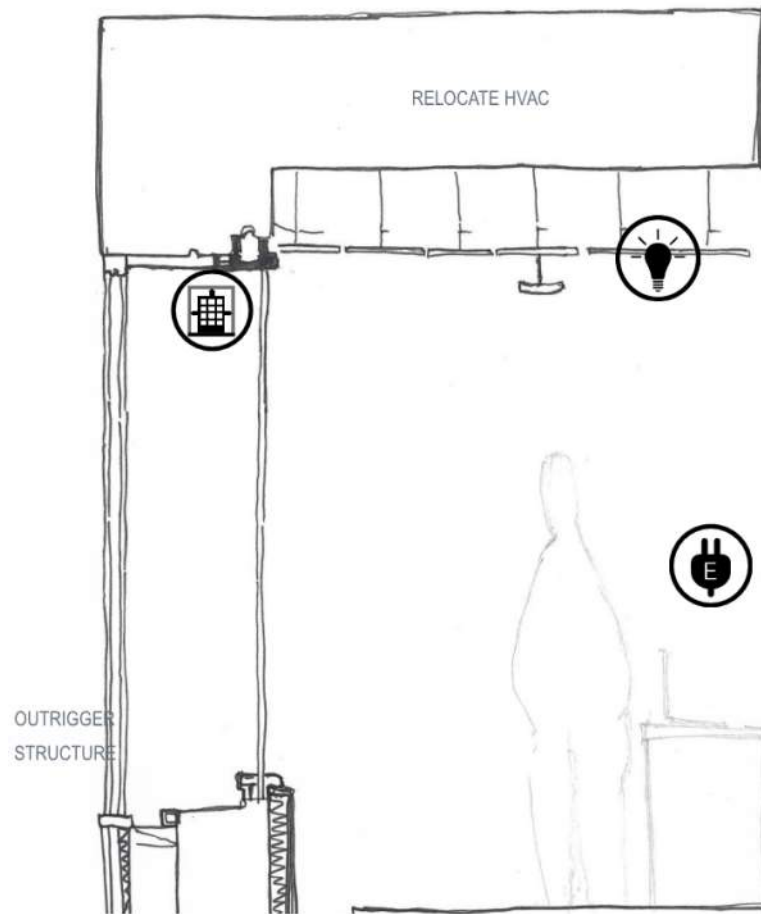
- Option 2: Overclad

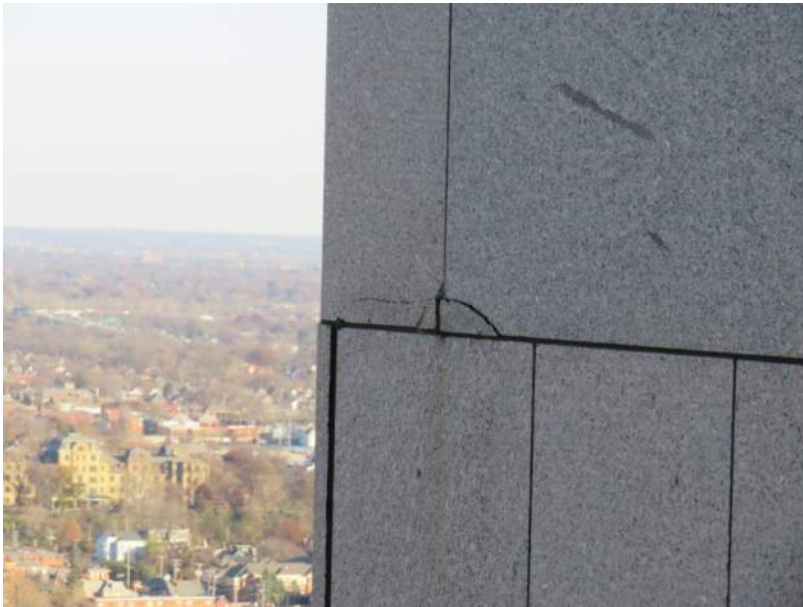
Granite Spalls

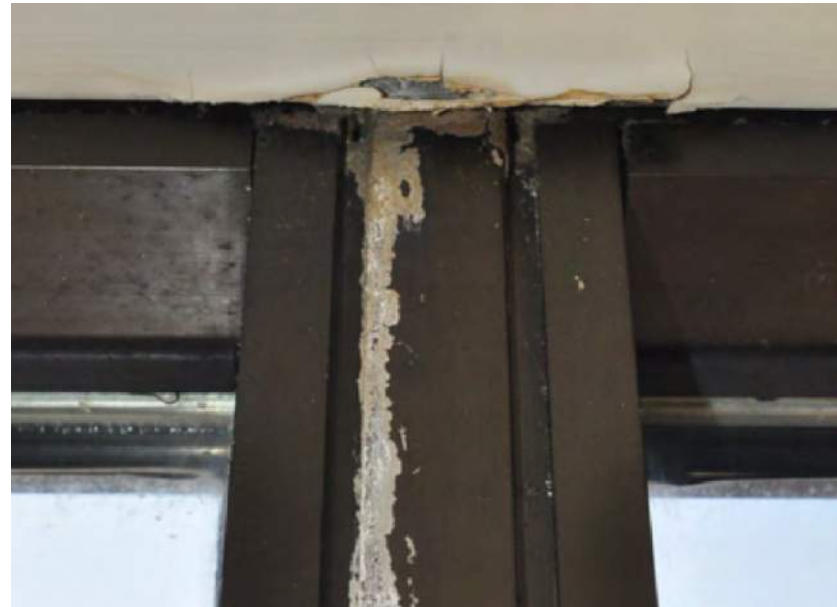
Water Infiltration at Windows

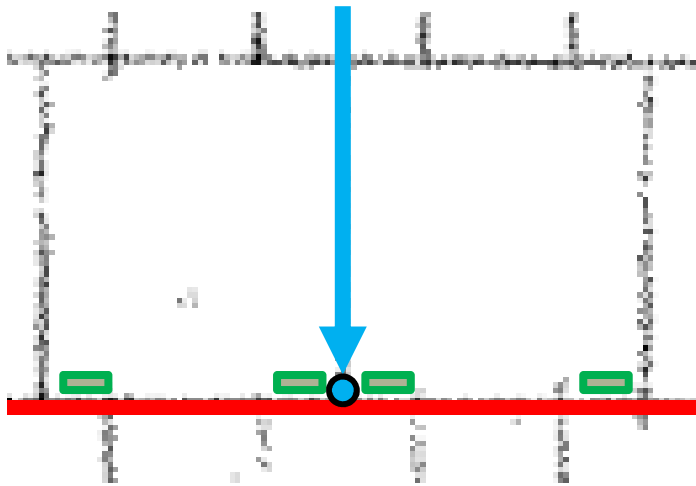
Enlarged Elevation

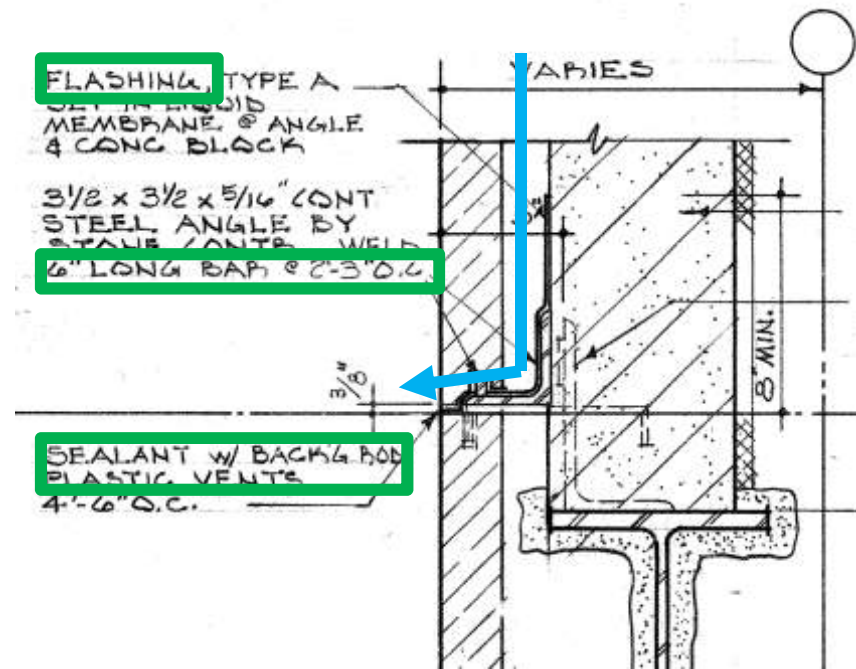
Section Detail

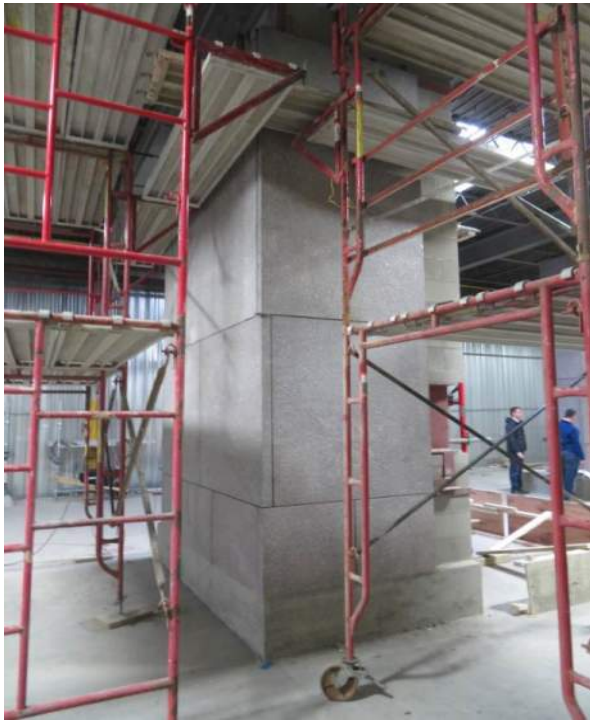
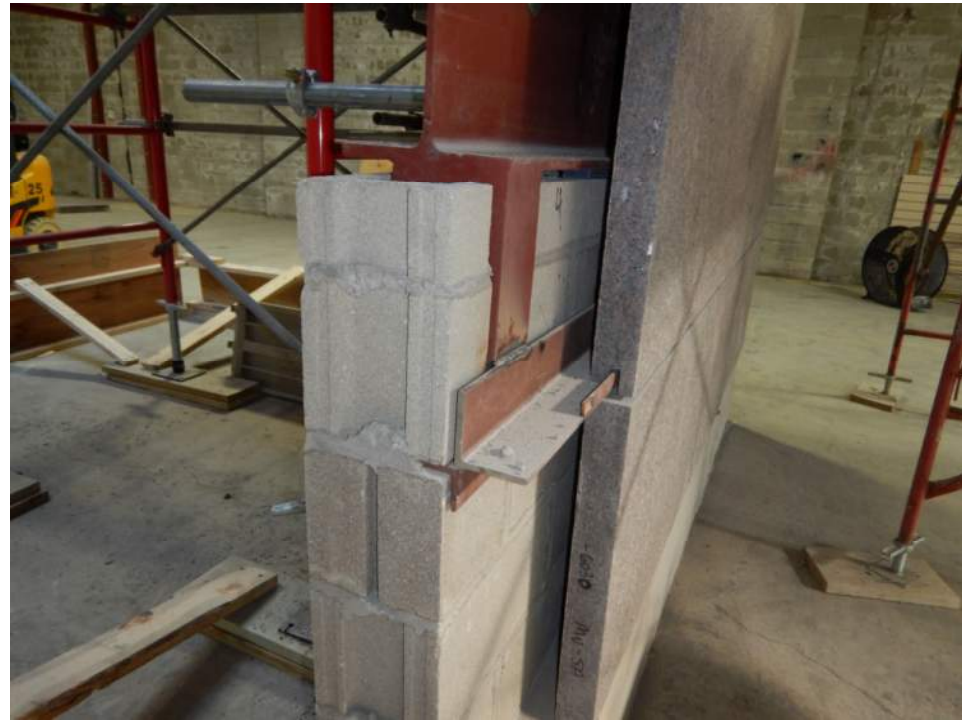
Design Assist - Mockup

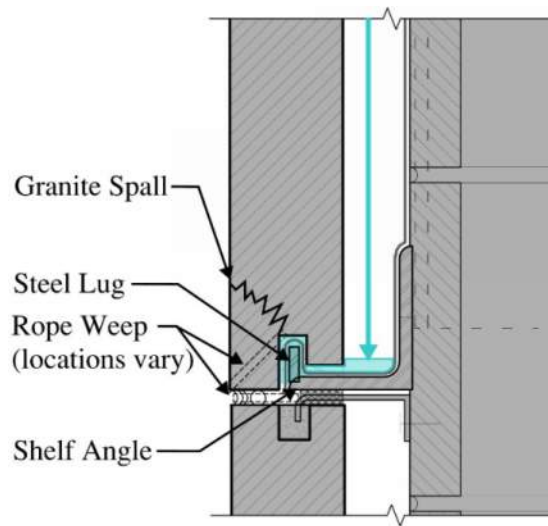
Existing

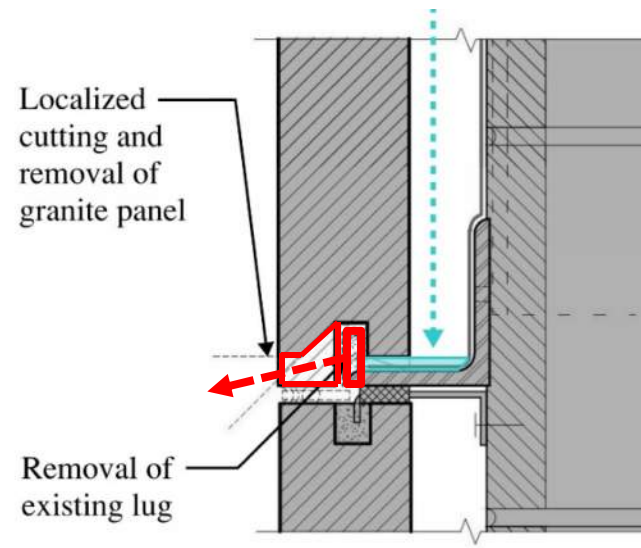
Demolition

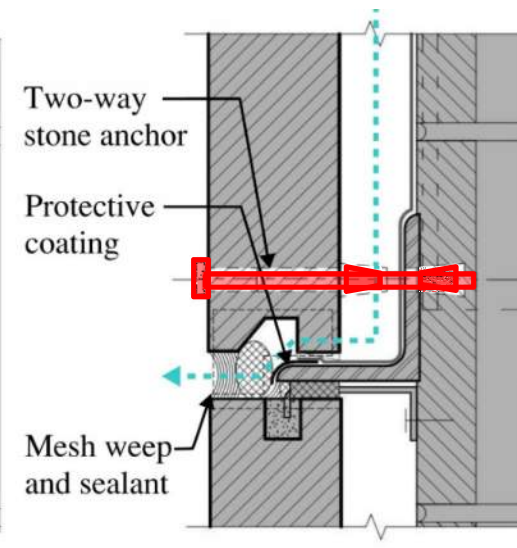
Repair

Repair Scheme

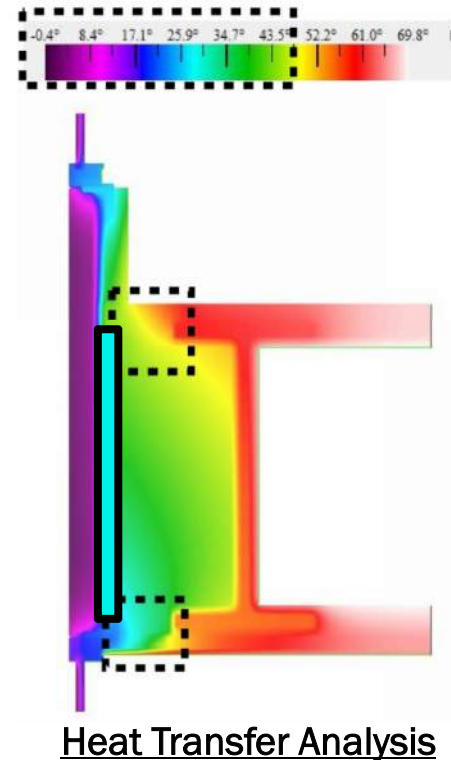
Approximate area of possible condensation

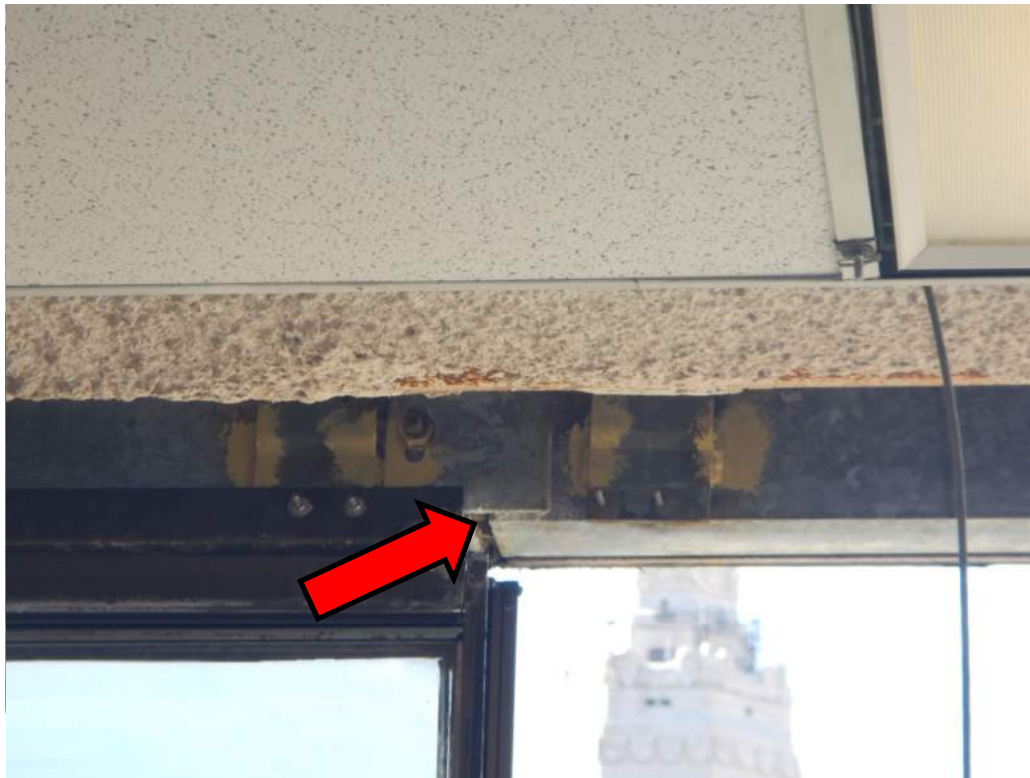
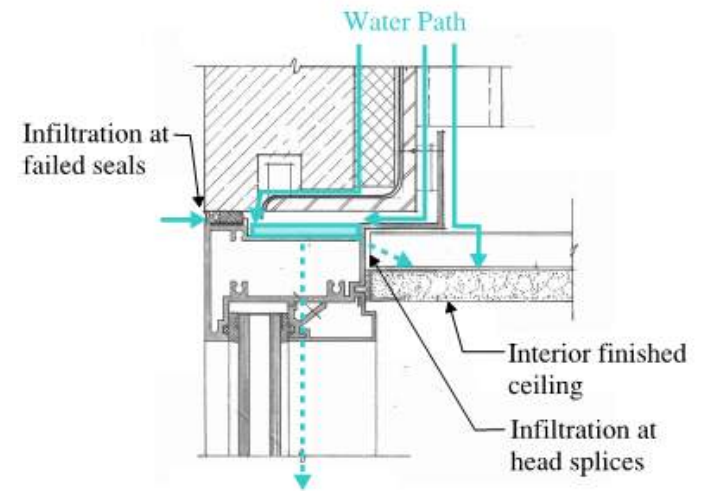
Head Detail

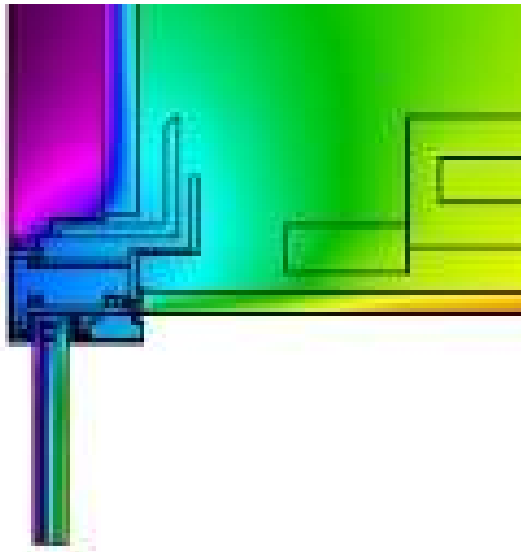
Existing Windows

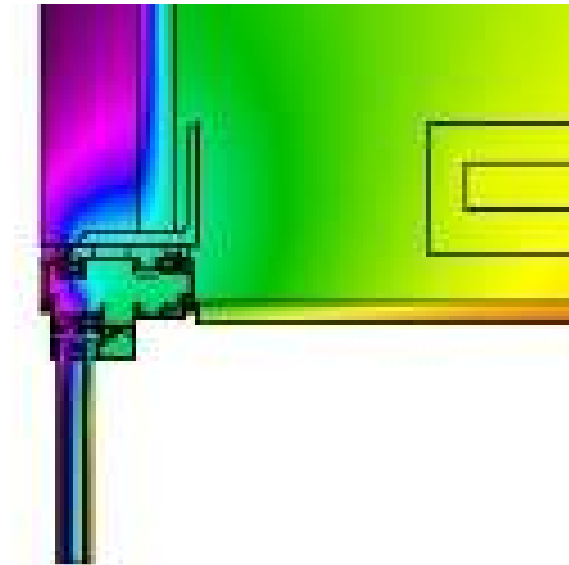
New Windows

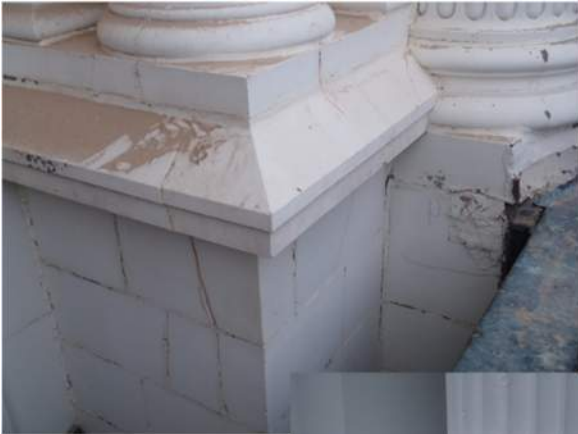
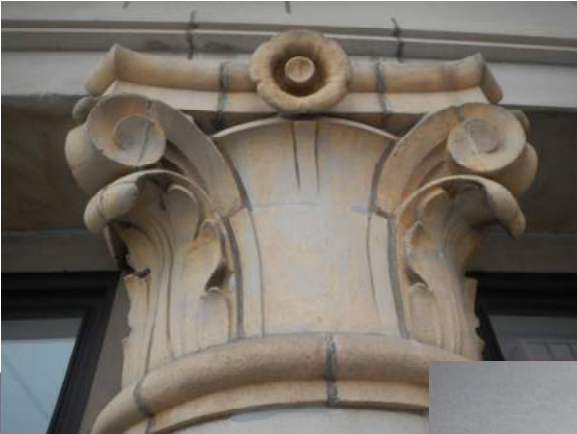
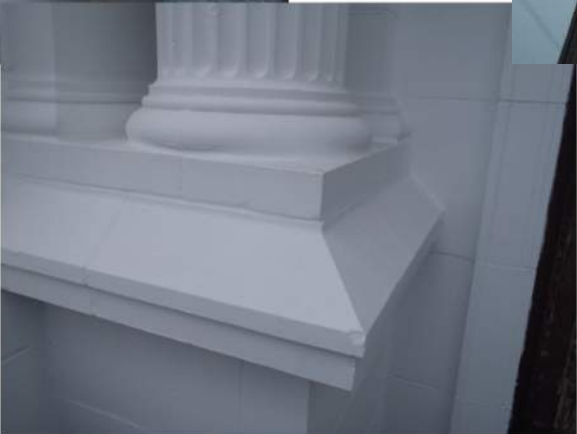
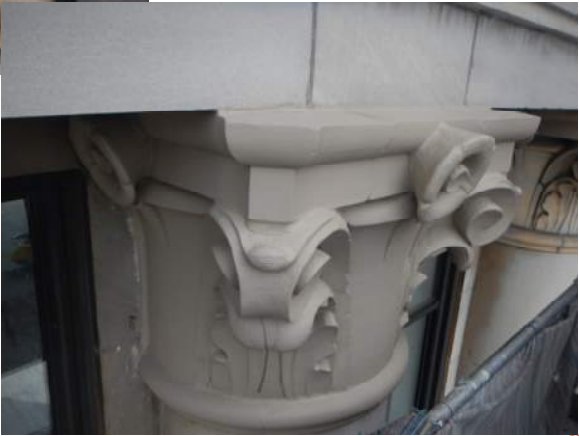
Examples of Terra Cotta Repairs

Unit repair/coating

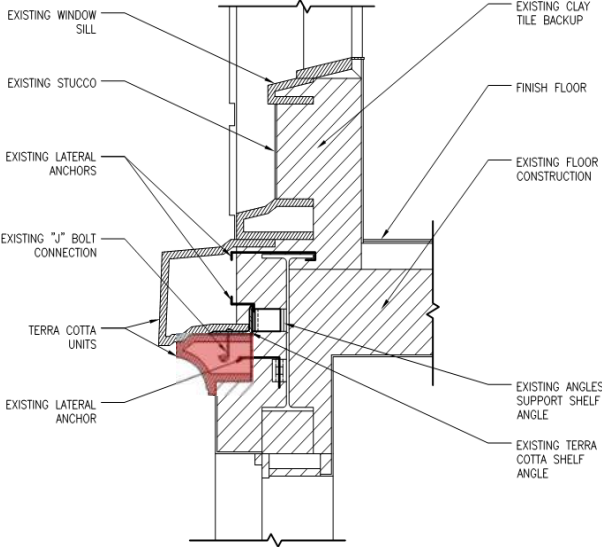
1 EXISTING WALL SECTION
 SCALE: 1" = 1'-0"

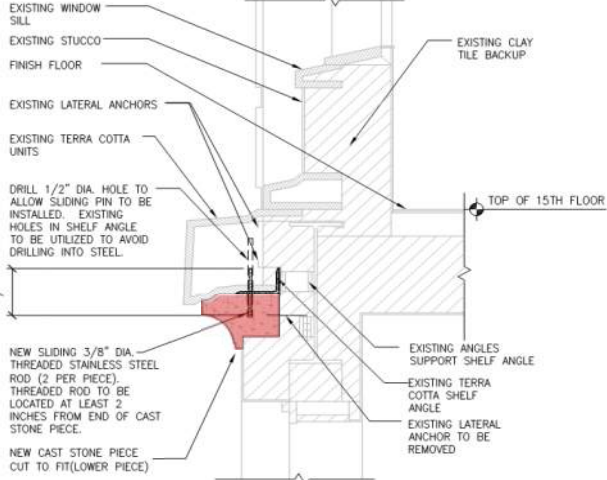
NOTE: THE 1/2" DIAMETER HOLE SHALL BE DRILLED INTO THE CAVITY OF THE ABOVE TERRA COTTA UNIT. DURING THE DRILLING, THIS SHOULD BE EVIDENT IF TERRA COTTA DEBRIS IS NOT BE NOTED AFTER THE DRILL BIT HAS PENETRATED 3-4 INCHES. IF THE HOLE EXTENDS BEYOND 3-4 INCHES, THE DRILL BIT HAS MOST LIKELY HIT THE RIB OF THE TERRA COTTA UNIT. IF THE HOLE IS LOCATED AT A RIB OF A TERRA COTTA UNIT, A NEW LOCATION SHALL BE SELECTED.

1 ATTACHMENT FOR LOWER CAST STONE PIECE
 SCALE: 1" = 1'-0"

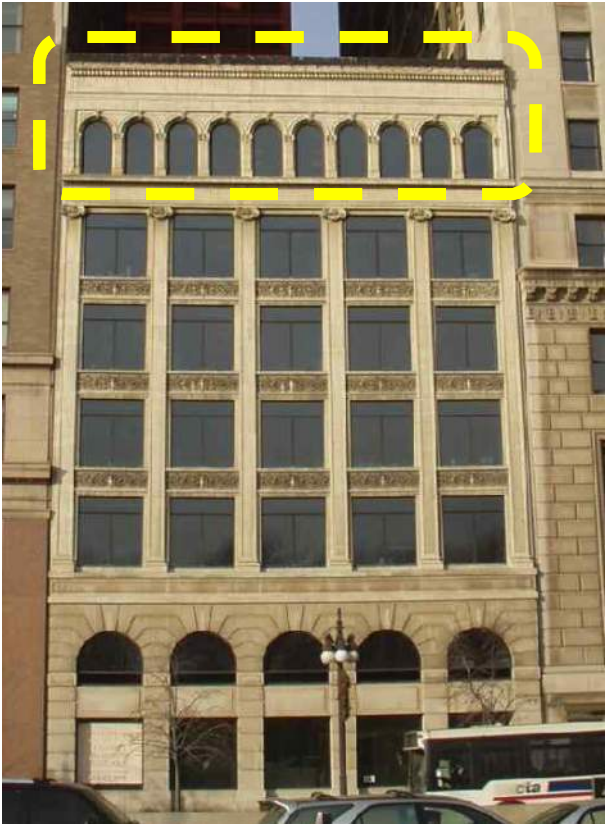
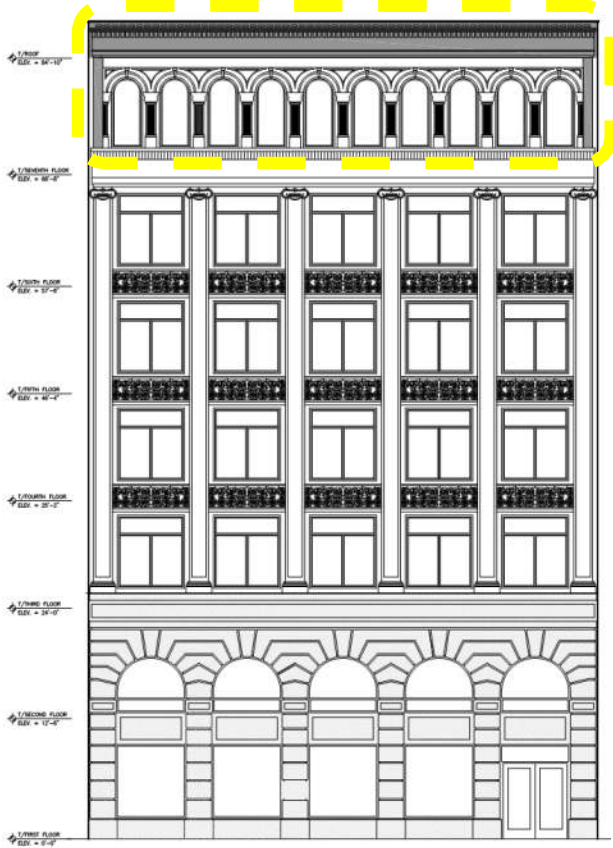
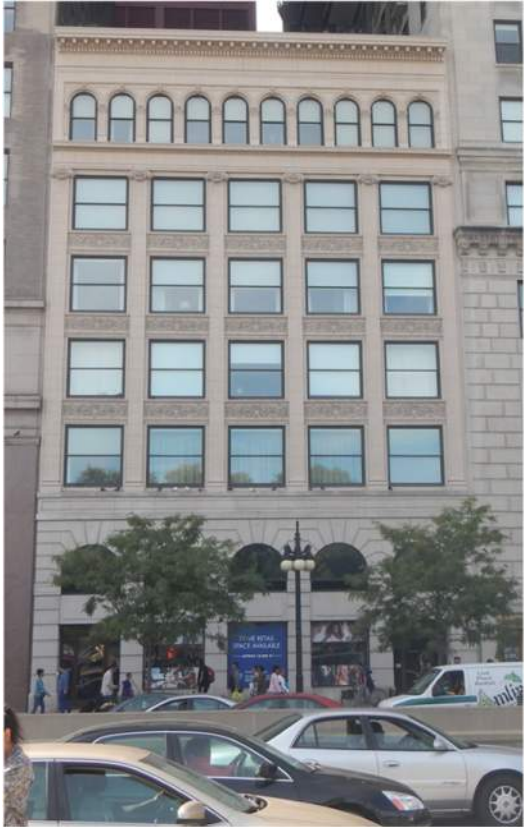
Example of Terra Cotta Replacement

Replacement with Glass Fiber Reinforced Concrete Panels

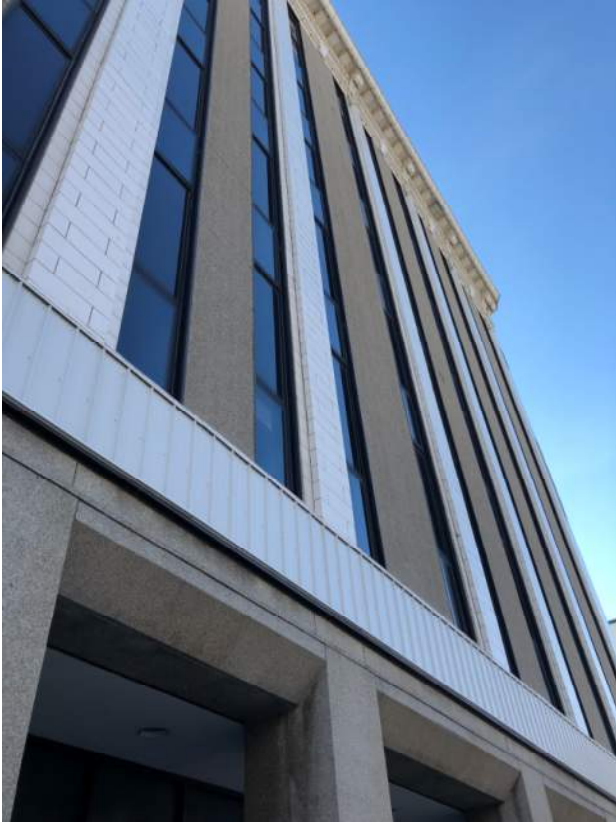
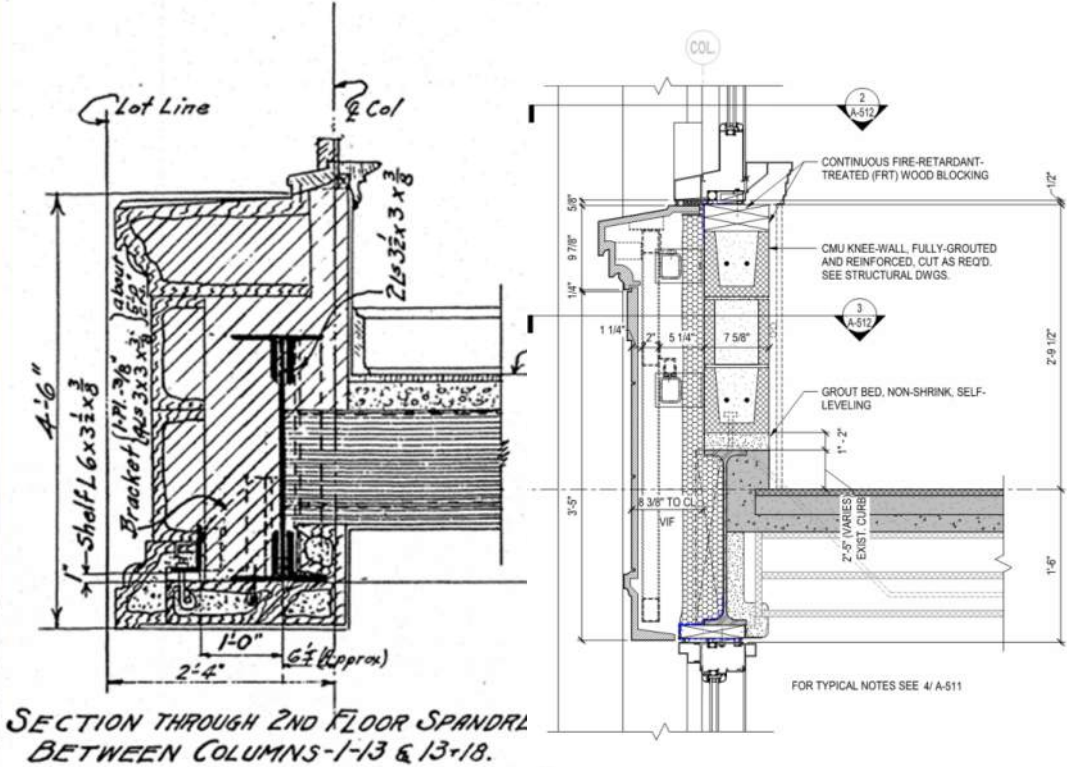
GFRC Replacement Spandrels

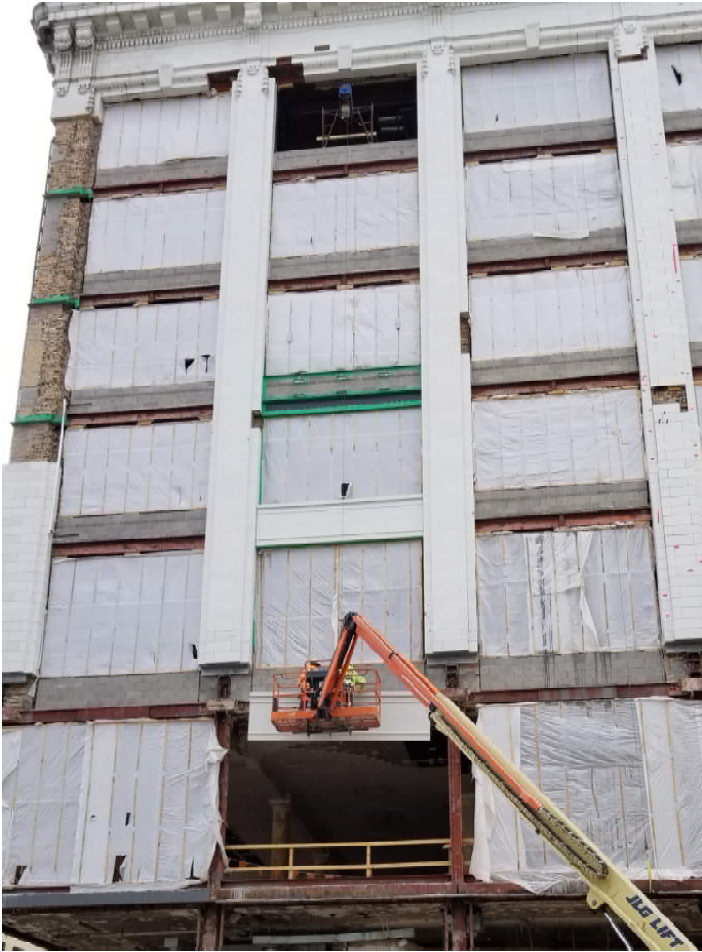
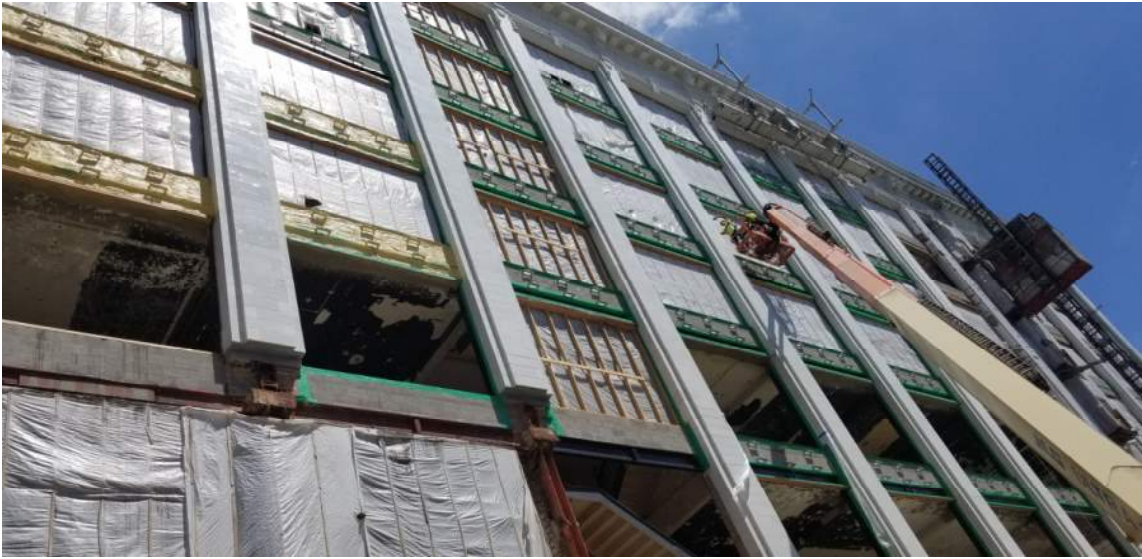
GFRP Replacement Spandrels

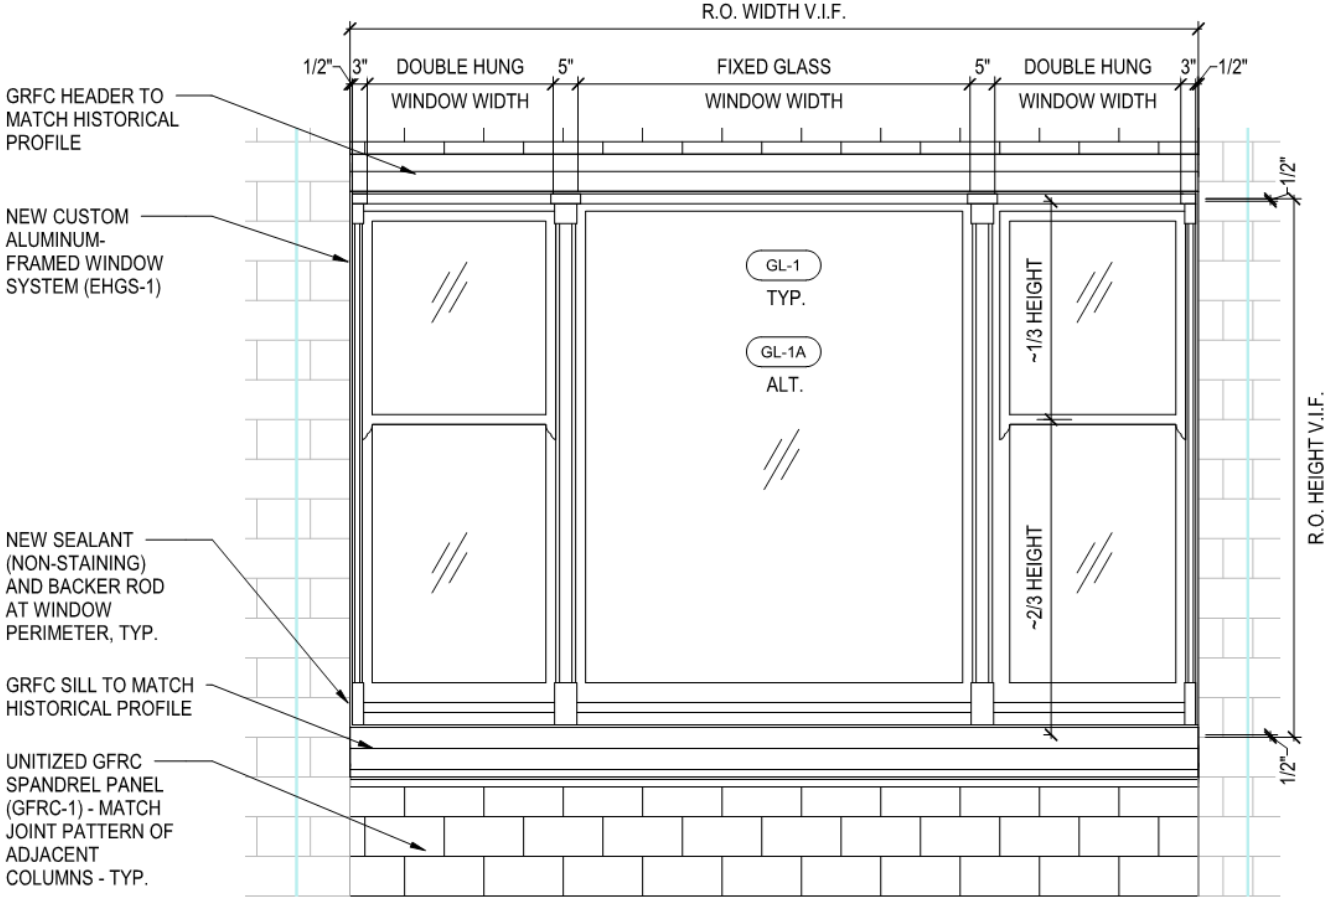
FOR ADDITIONAL DETAIL, SEE 2/ A-511

Replacement Windows Systems

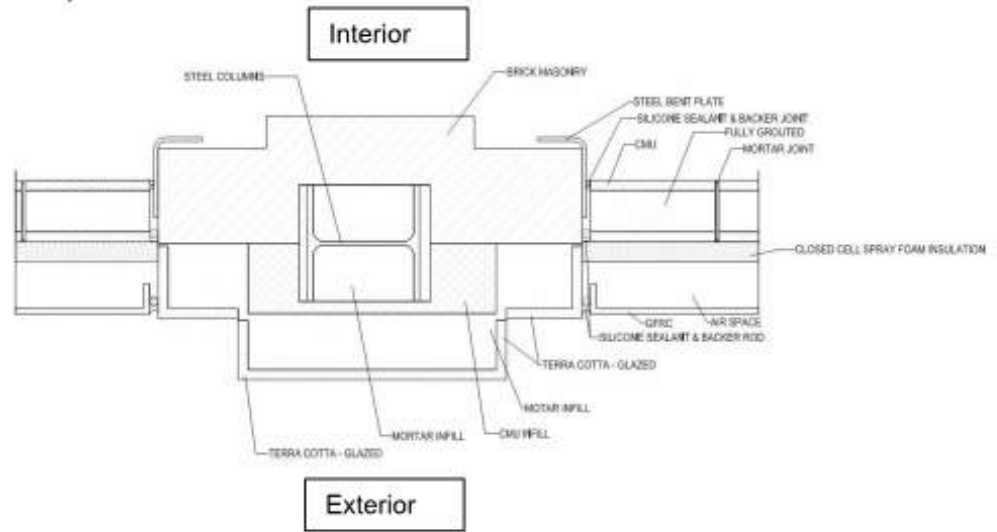
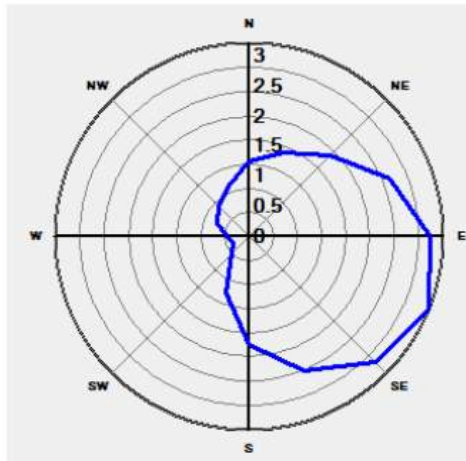
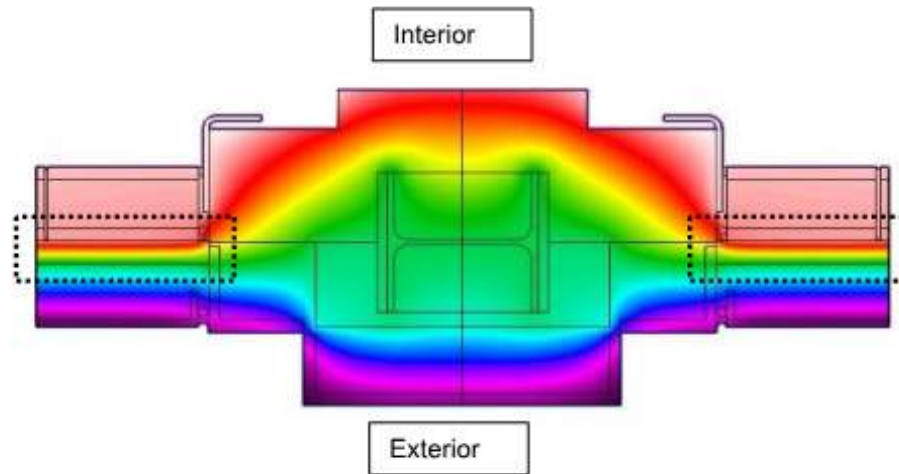
Outside Air Temperature 0°F
 Inside Air Temperature 70°F
 Inside Relative Humidity 50%
 Inside Dew Point Temp 51°F

1.9° 8.7° 15.5° 22.4° 29.2° 36.0° 42.8° 49.6° 56.5° F

Hygrothermal and Heat Transfer Analysis
