# Existing/Historic Structures

## A Metallurgical Perspective

James A. Brusso, Ph.D., P.E.

# American Swedish Institute – Carriage House

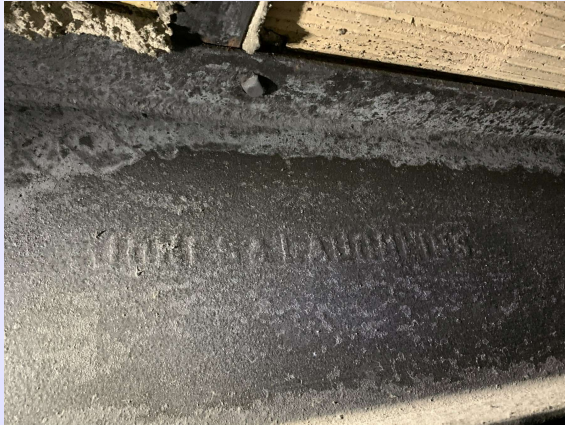
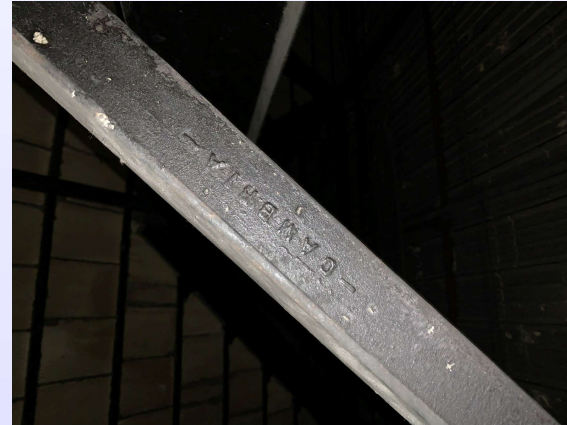
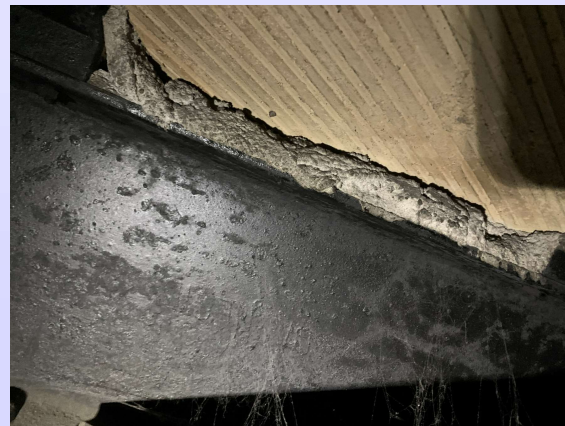
## Exposed Beams - Identification of Steel Producers for Various Members

- Preliminary site visit to develop sampling plan prior to demolition
  - Exposed beams in attic space
  - Identified three steel beam producers
- Sample procurement for laboratory testing
  - Samples from structural members in areas to be modified
- Quantitative chemical analysis
- Tensile testing
- Metallography/microstructures
- Assessment of weldability

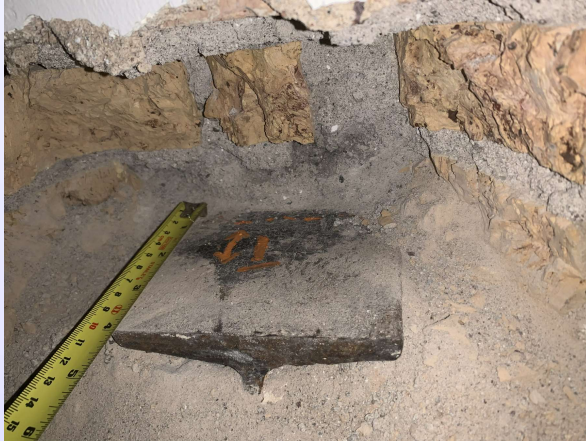
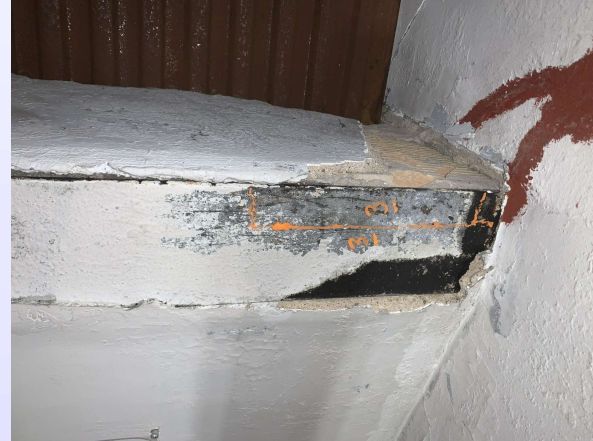
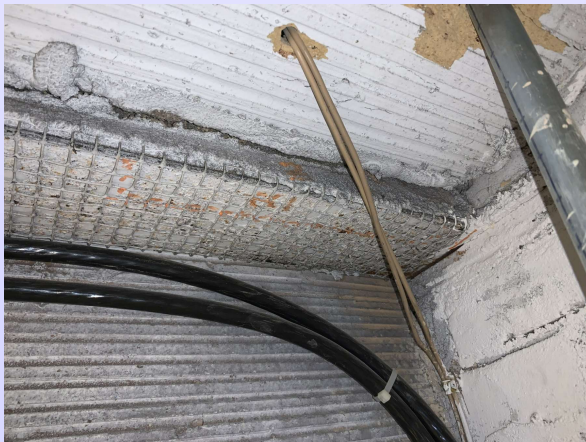
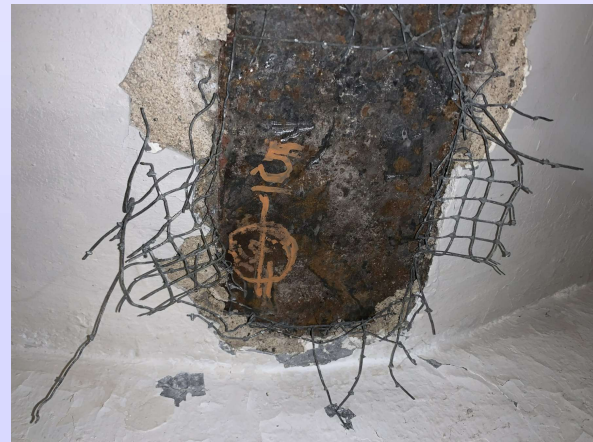
## Sampling of Representative Steel Members

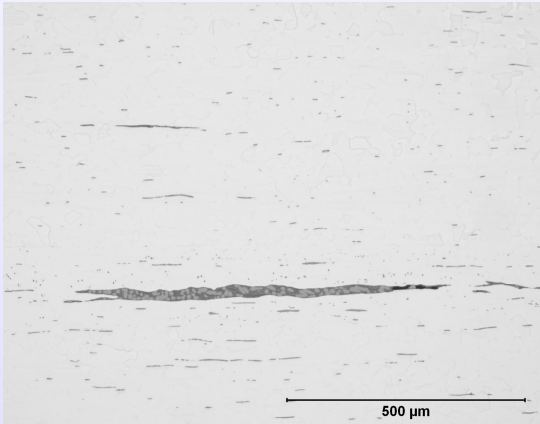
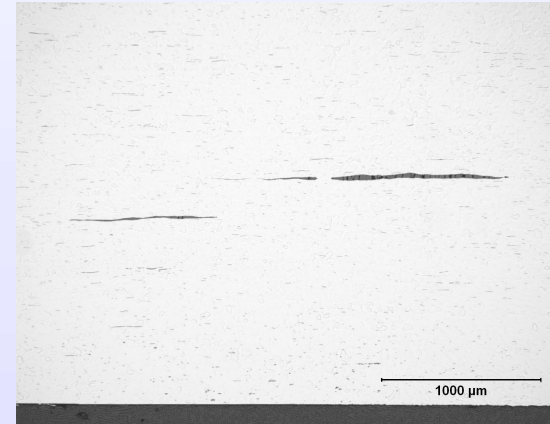
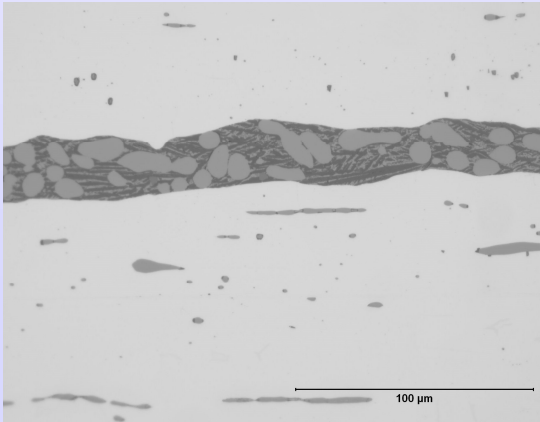
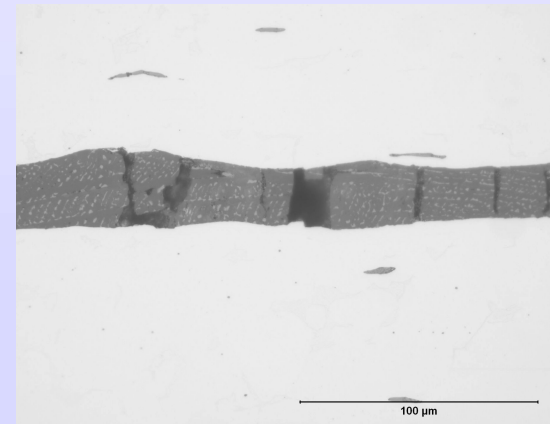
## Microstructure Evaluation

3. Although the carbon equivalents of the beams at the ASI Carriage House are low, suggesting good weldability, the high sulfur and phosphorus contents and presence of large non-metallic inclusion stringers indicates that the weldability will be poor. Although welding may be possible, welding should not be done without development of qualified weld procedures. Any structural welds produced will require thorough non-destructive inspection.
