Diagnostic Procedures for Understanding Existing Construction

Minnesota Structural Engineers Association
2023 Spring Seminar
May 9, 2023

Atkinson-Noland
& Associates

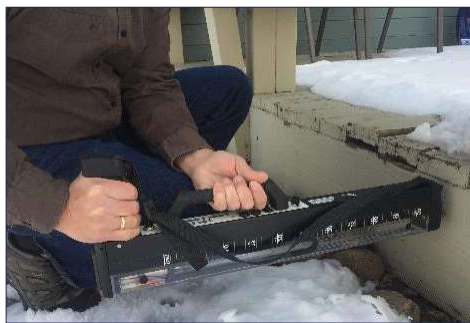
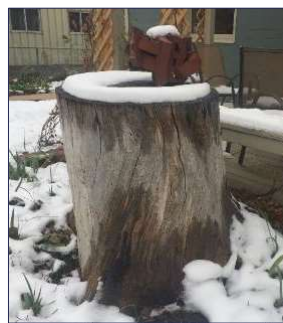
Resistance Drilling

- ▣ Wood "hardness" - Measures *resistance*
- ▣ Can locate decay not visible on the member surface

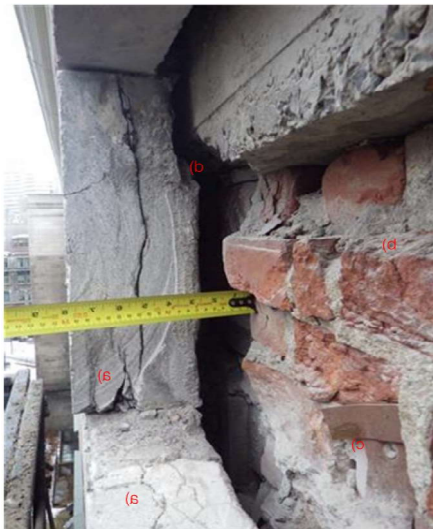
Ultrasonic B-scan

Intact stone

Back of stone

Damaged stone

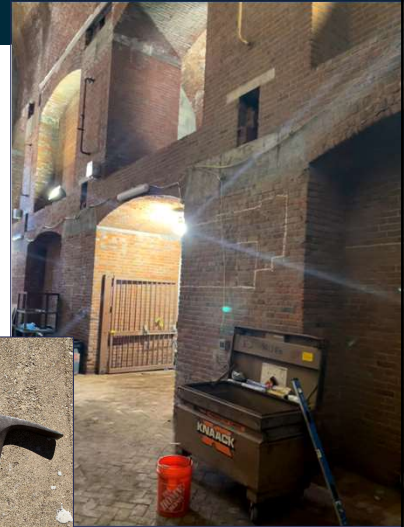
Sounding

- Hollow vs. solid
- Near-surface delaminations
 - Plaster delaminations
 - Spalls, separations
- ASTM C4580
Chain-drag method – bridge deck delaminations

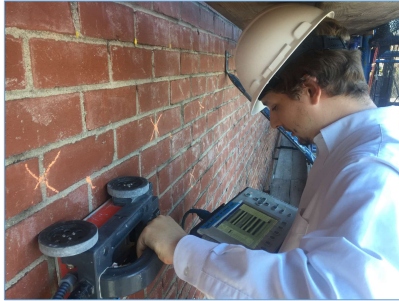
Acquiring a radar trace (SPR)

GSSI Mini XT Image Source: Line Surveying

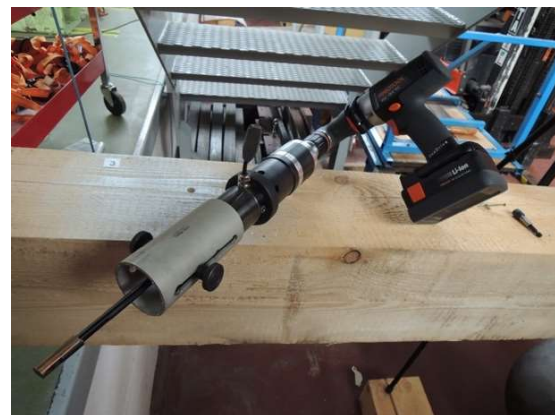
Wood load-jacking

- ▣ Emerging method for performing compression stress-deformation measurements directly on a wood member in situ

Surface area of
jack

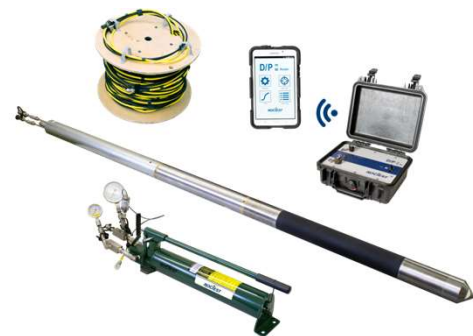
Borehole dilatometer

- In situ deformability: compression modulus

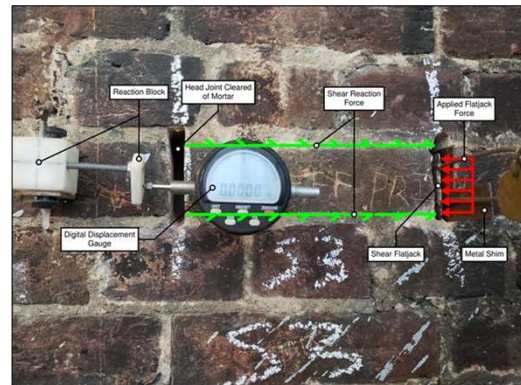
Shear Test - Bed Joint Shear Strength

ASTM C1531, Standard Test Methods for Determination of Masonry Mortar Joint Shear Strength Index
