Wood in Historical Structures

Durability and Longevity of Wood Surround

Minneapolis East Interceptor

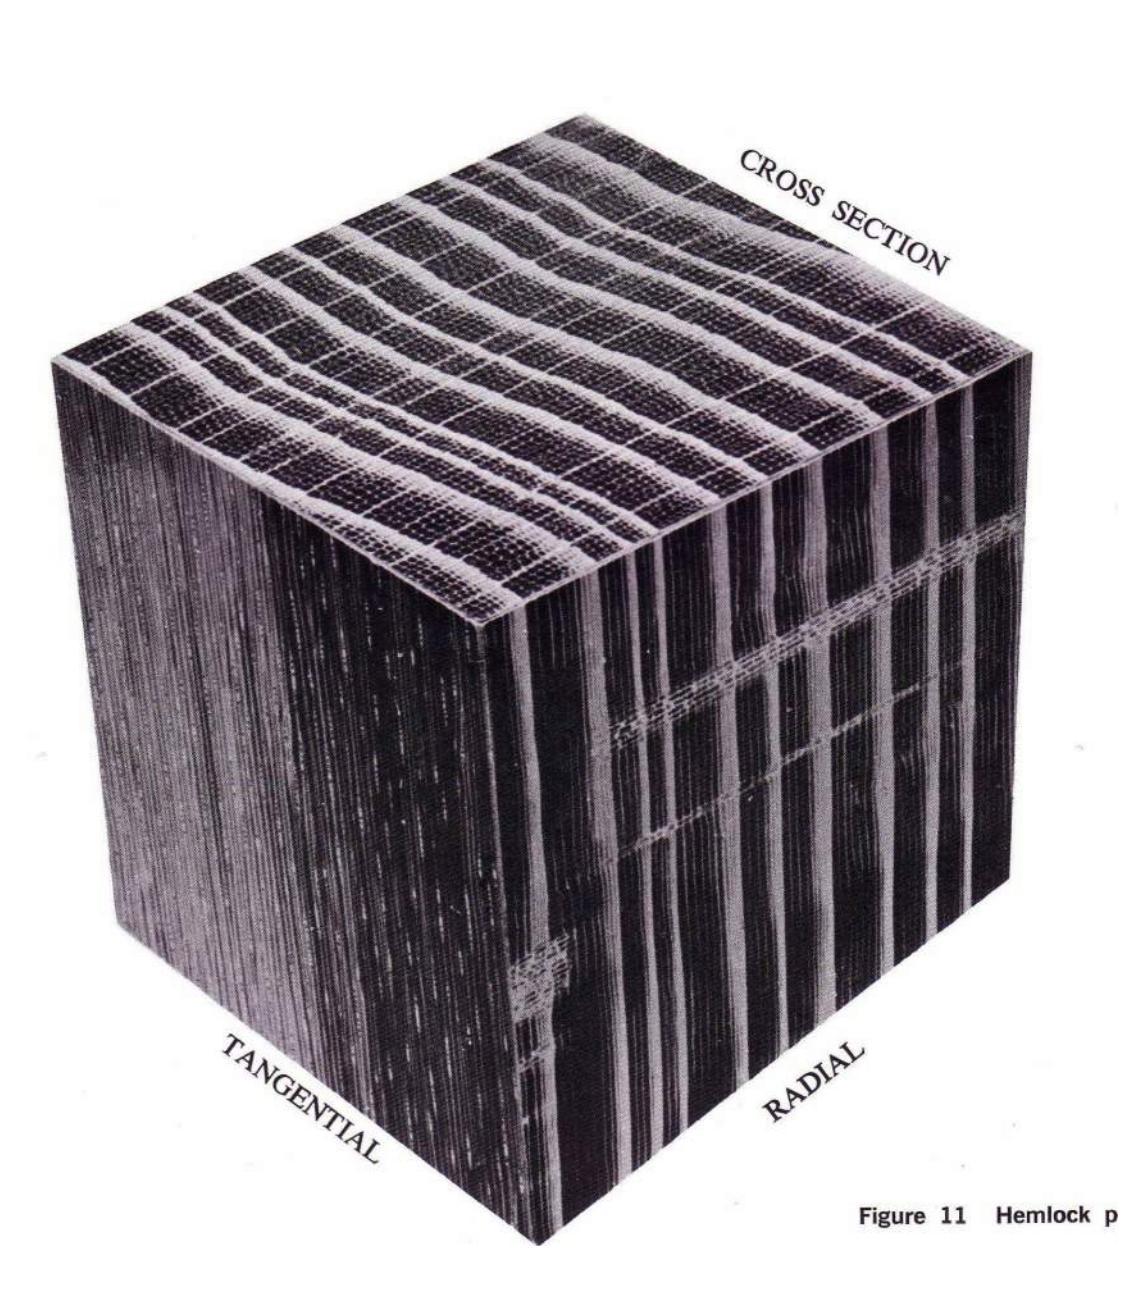
Consider wood as soda straws grouped together – running vertically in the tree trunk

- Longitudinal tracheids have cell walls that surround the hollow lumen
- In service, wood is dried, but continues to gain / lose water (cell walls) with changes in humidity

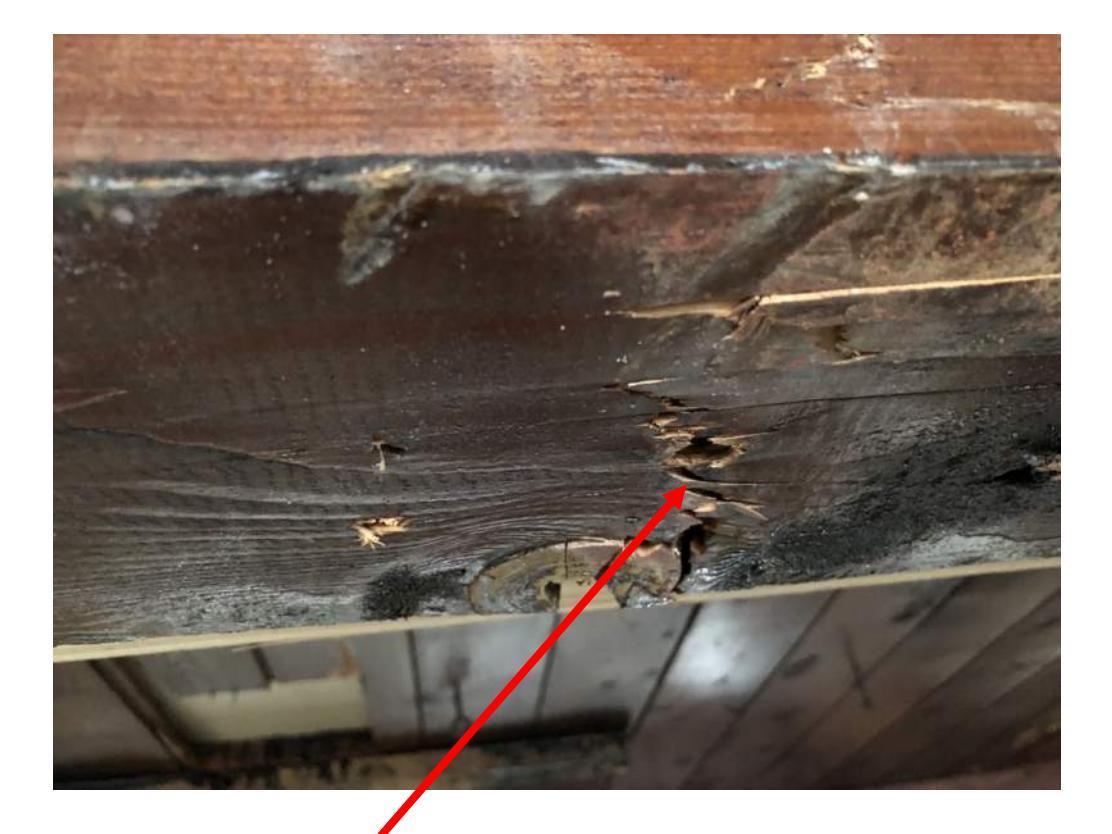
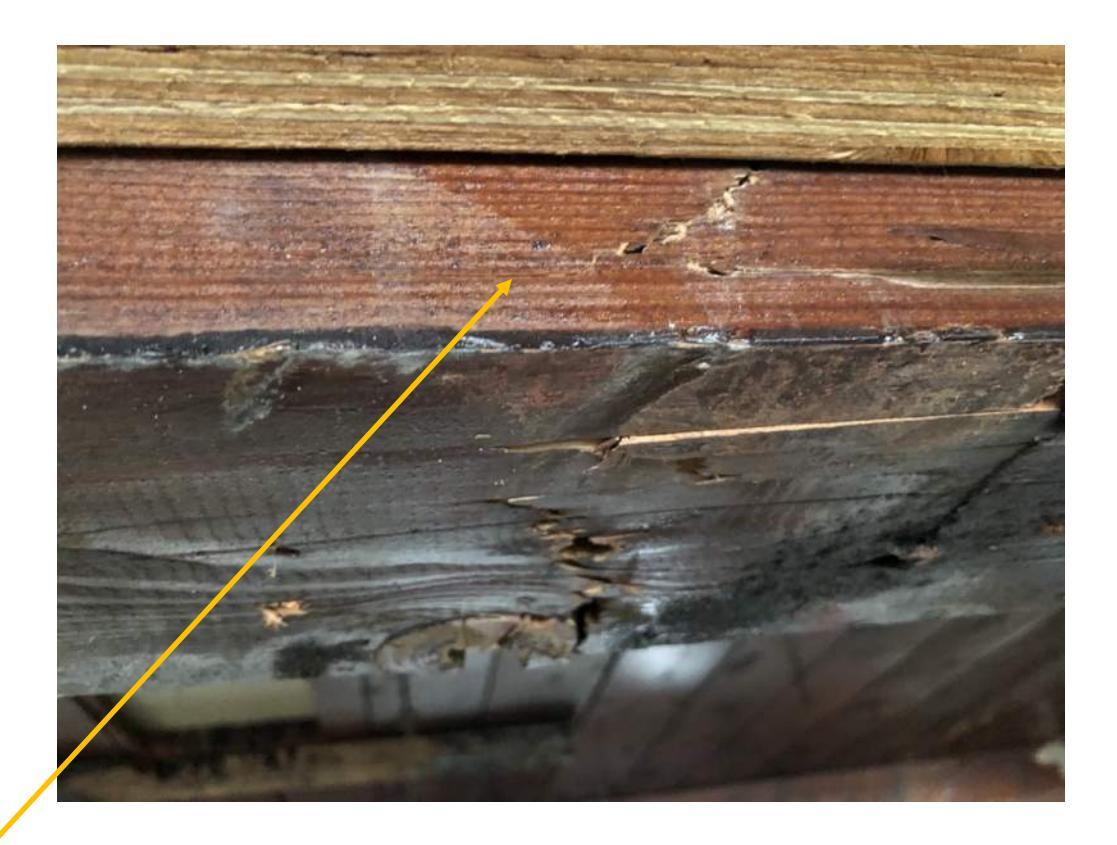
Beam #7 with the crack at the bottom and showing how the crack shows up on the side of the beam. Note also the LVL that is bolted to the sides (both side of beam).
